August 16, 2023

# **Monarch Consulting Arborists**

## Summary

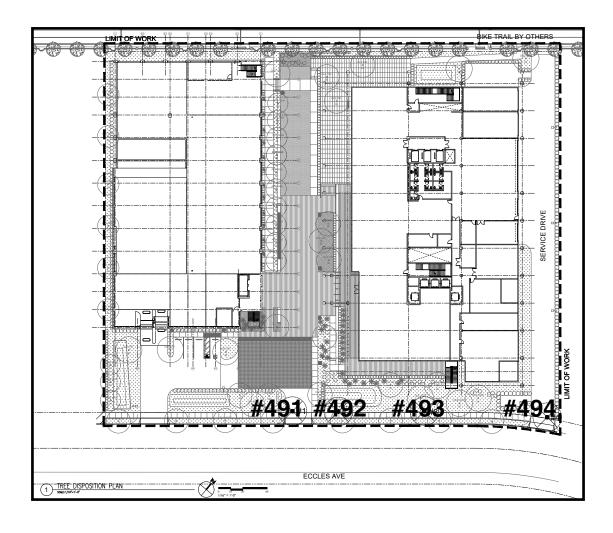
The image below indicates the locations of the trees included in the inventory from L.005 (Image 1) and the data summary.

Tree Species	I.D. #	Trunk Diameter (in.)	~ Height (ft.)	~ Canopy Diameter (ft.)	Condition	Expected Impact	Status
London plane (Platanus x Hispanica)	491	31	35	30	Fair	High/ Remove	Non-Heritage Species
London plane (Platanus x Hispanica)	492	22	35	30	Fair	High/ Remove	Non-Heritage Species
London plane (Platanus x Hispanica)	493	22	35	30	Fair	High/ Remove	Non-Heritage Species
London plane (Platanus x Hispanica)	494	19	35	30	Fair	High/ Remove	Non-Heritage Species

All four trees are to be removed and replaced with thirteen additional specimens throughout the site.

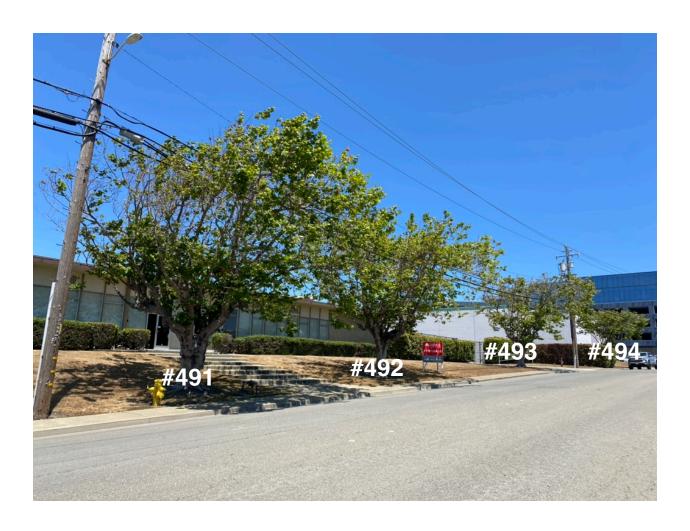
A1: #491 through #494

All the trees are in fair condition and have suffered from various common leaf diseases such as Anthracnose (*Apiognomonia veneta*). and sycamore scale (*Stomacoccus platani*). All four trees have been and would require arbitrary crown height reduction to accommodate the overhead high voltage lines.

Although the trees are in fair condition all four are a burden to the community because they require constant reduction by the electric utility to keep them away from the high voltage lines. Removing and replacing the trees with more power line friendly species would be appropriate in this instance when the property is to be renovated. In this circumstance the trees have poor suitability for preservation.

Obtain all necessary permits and remove the trees and replace them according to the ordinance or planning requirements.
