FACILITY CONDITION ASSESSMENT

South San Francisco Municipal Building
33 Arroyo Drive
South San Francisco, CA 94080

162502.24R000-001.017

October 29, 2024

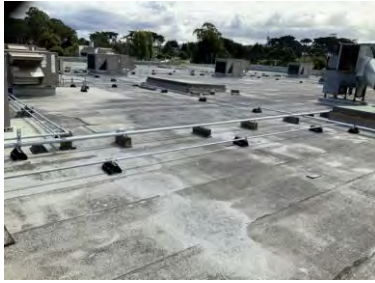
Roofing in Poor condition.

Modified Bitumen
001 - South San Francisco Municipal Building
Roof

The roofing has active leaks, and it is showing a lot of bubbled areas - AssetCALC ID: 8180986

Uniformat Code: B3010
Recommendation: **Replace in 2025**

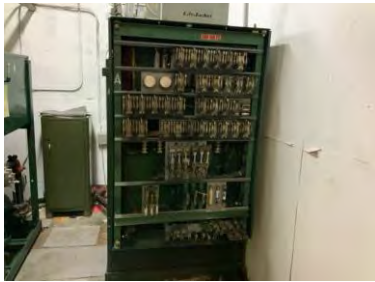
Elevator Controls in Poor condition.

Automatic, 2 Car Cluster
001 - South San Francisco Municipal Building
Elevator Shafts/Utility

Very choppy ride - AssetCALC ID: 8180832

Uniformat Code: D1010
Recommendation: **Replace in 2025**

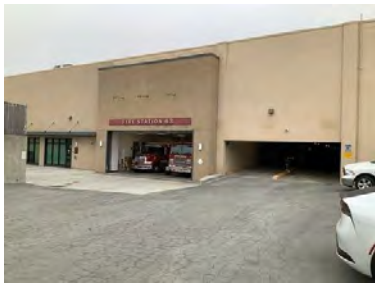
Parking Lots in Poor condition.

Pavement, Asphalt
001 - South San Francisco Municipal Building
Site

This needs to be done after the asphalt is replaced - AssetCALC ID: 8180917

Uniformat Code: G2020
Recommendation: **Seal & Stripe in 2025**

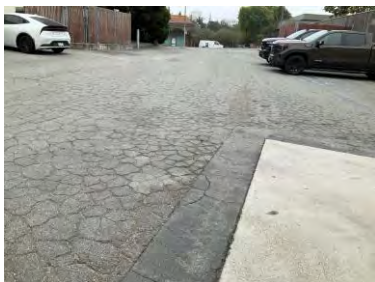
Parking Lots in Poor condition.

Pavement, Asphalt
001 - South San Francisco Municipal Building
Site

Lots of alligator cracking and tree root damage - AssetCALC ID: 8180922

Uniformat Code: G2020
Recommendation: **Mill & Overlay in 2026**

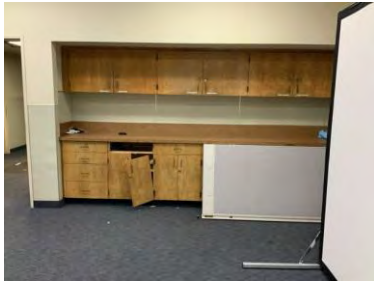
Casework in Poor condition.

Cabinetry, Standard
001 - South San Francisco Municipal Building
Throughout Building

Uniformat Code: E2010
Recommendation: **Replace in 2026**

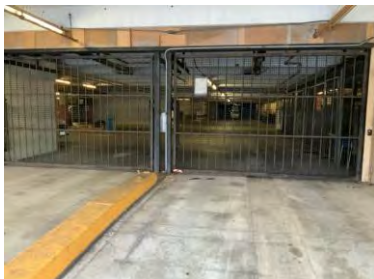
Fences & Gates in Poor condition.

Vehicle Gate, Chain Link Sliding Electric
001 - South San Francisco Municipal Building
Site

Very rusty - AssetCALC ID: 8180859

Uniformat Code: G2060
Recommendation: **Replace in 2026**
