## Arborist Report

**500 Railroad Avenue  
South San Francisco, CA**

**March 2024**

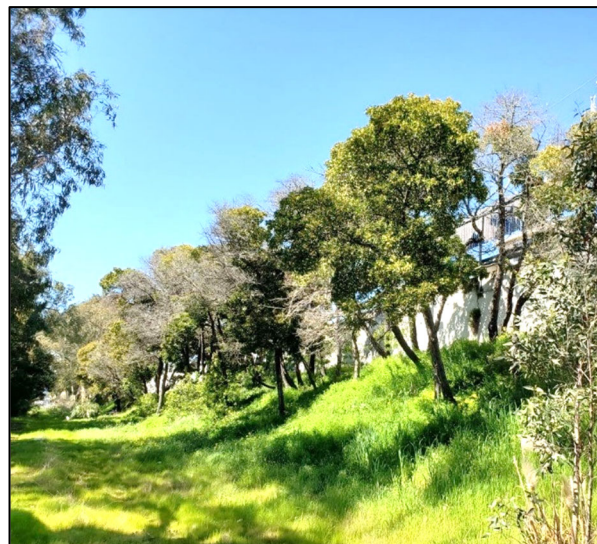
Blackwood acacia was the most frequently occurring species, with 31 trees. Most were growing on the north slope near Railroad Avenue (Photo 1). Condition was almost uniformly poor (30 trees), due to over-crowding and extensive dieback.

**Photo 1.** Most acacia were growing on a slope below Railroad Avenue.

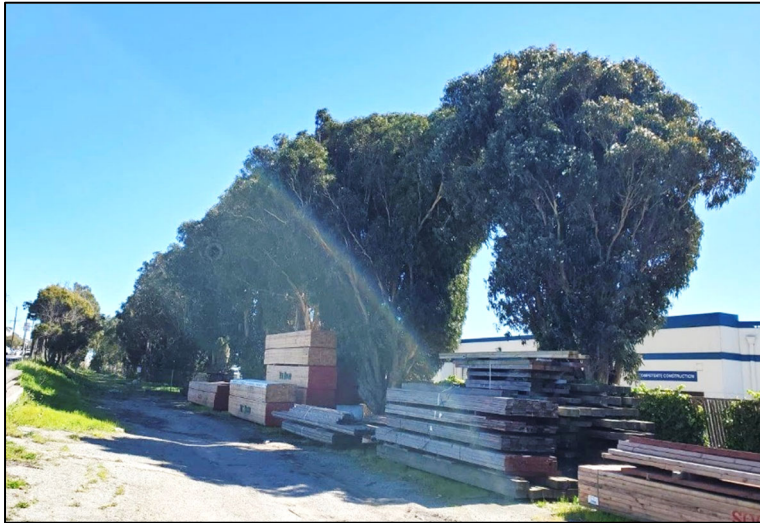
Twenty-one (21) compact blue gums were growing at the edge of the site (Photo 2). Nine were off-site behind a fence on the south side. Most gums (17 trees) were large mature trees in fair condition. Four compact gums were in poor condition due to crowded growing

**Photo 2.** Compact gums #97 and 98 (at right) were growing at the west end of the property. Gum #98 was off-site behind a fence.

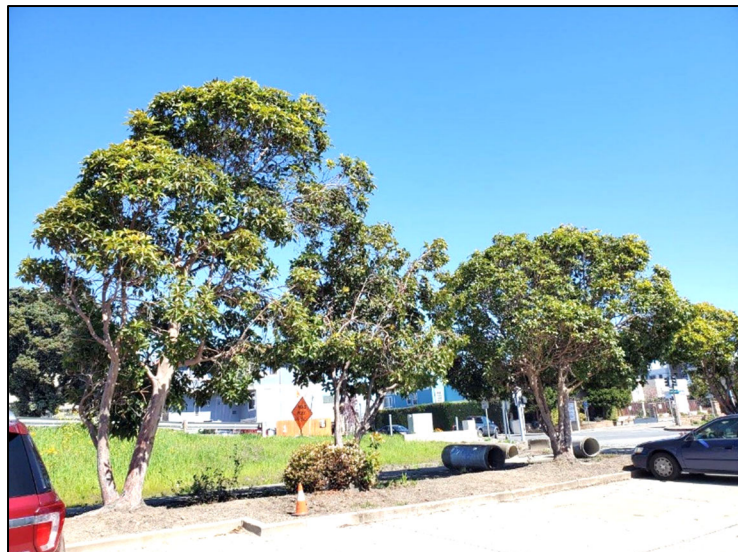
Fifteen (15) Brisbane boxes were in fair (10 trees) or poor condition (5 trees). Several were multi-stemmed at or near the base. Stem diameters ranged from 2 to 19 inches. Six trees were growing off-site (Photo 3).

**Photo 3.** Brisbane boxes #90, 91 and 92 (L to R) were growing off-site at the southwest edge.
