RE: **2400 WESTBOROUGH BOULEVARD**
COMMERCIAL CONDO CONVERSION
Property Condition Assessment Report

Property Condition Assessment

Re: City of South San Francisco Incompleteness Letter, November 1, 2018
Section 19.80.160 – Structural Condition of Building Evaluation
2400 Westborough Blvd. - Commercial Condominium Conversion
South San Francisco, CA 94080

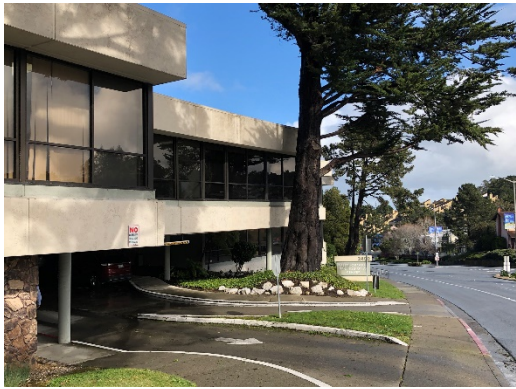
Fig 1 – South Side

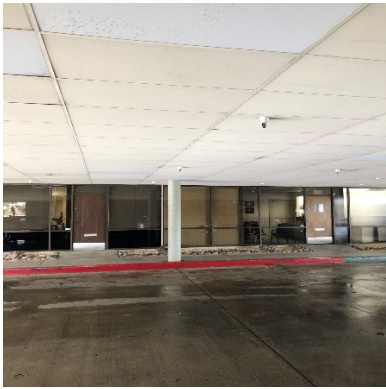
Fig 2 – Drive-Through

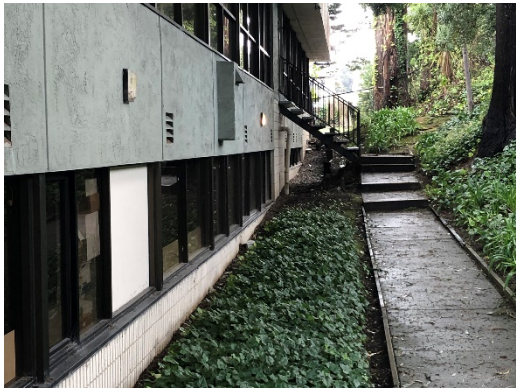
Fig 3 – West Side

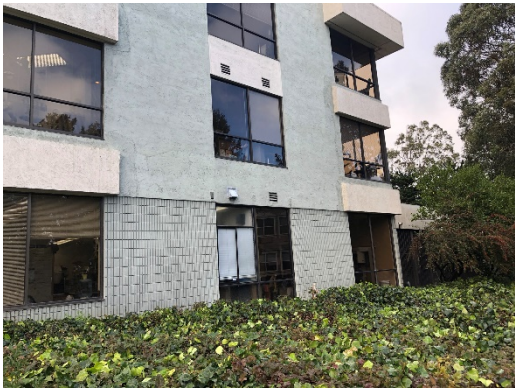
Fig 4 – East Side

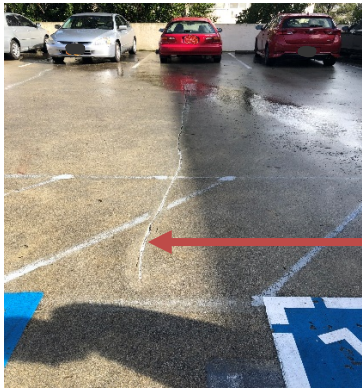
As described above, the building had very few signs of repair, modifications or alterations. It is noted that the parking deck had some cracks that appeared to be repaired with some form of epoxy material. The cracking was minor over the area of the slab, and the repair was most likely an attempt to limit water penetration through the deck to the parking below. The crack repairs are not considered alterations or modifications to the deck, and do not change the original design demand load or capacity of the deck.

Crack
Repair

Fig 5 – East Parking Deck

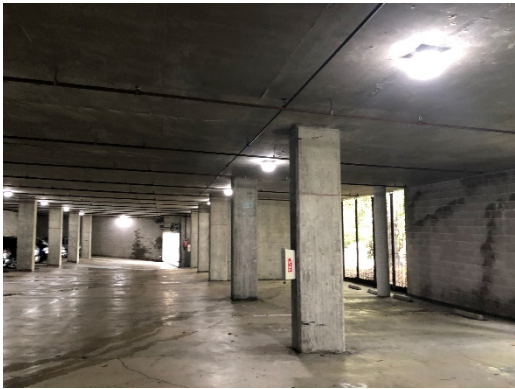
Fig 6 – Lower Parking

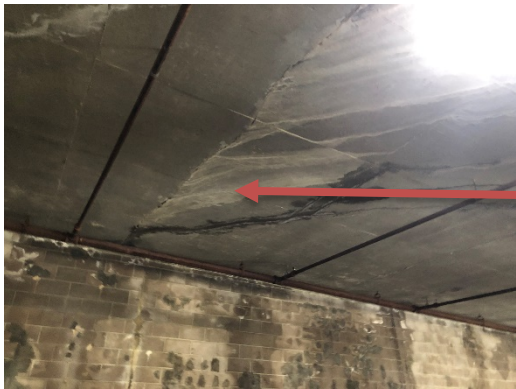
Efflorescence

Fig 7 – Efflorescence Under Deck

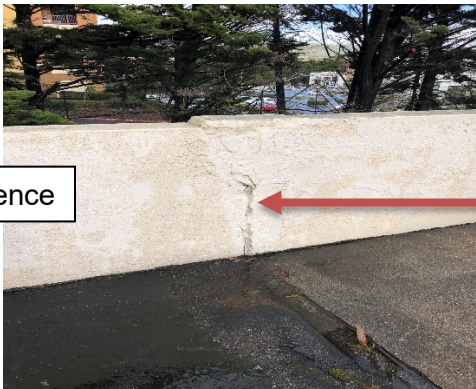
deck, the north guardrail wall shows a vertical trending crack (fig 8). This is an indicator that the guardrail wall is partially on a foundation at grade and partially on a concrete deck. Differential settlement and/or incompatible deformations between the concrete deck and grade promote cracks of this type. It is essentially a cosmetic crack which can be repaired using proper methods to insure better performance in the future.

17. There are masonry guardrail walls along the edge of the parking area that are covered in stucco. The walls are in good shape with the exception of a proper control joint where the wall on deck continues into a wall on grade. The west masonry retaining walls above the main parking are in good shape and show no signs of distress. The basement walls of the building are masonry and did not show any signs of distress. The retaining wall for the lower parking area does have water penetration issues and it is recommended that a repair method be scheduled in the near future. The structural integrity of the entire wall is not compromised; however, local zones do need attention.

Transition
Crack

Fig 8 – Masonry Wall Crossing Joint

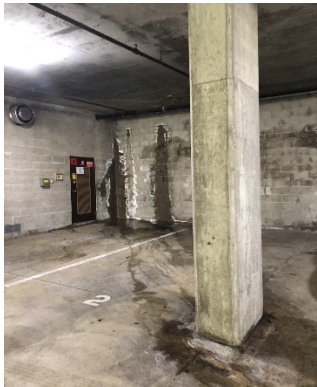
Fig 9 – Garage Column

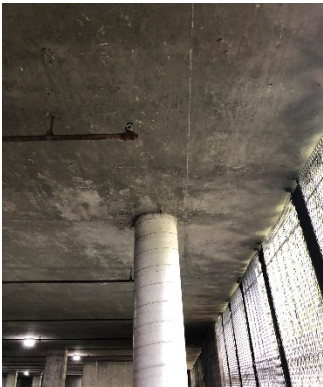
Fig 10 – Garage Column

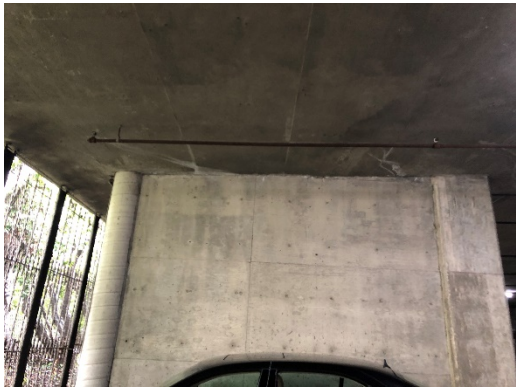
Fig 11 – Concrete Shear Wall

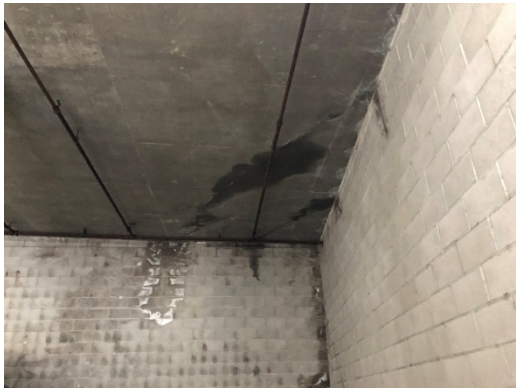
Fig 12 – Garage Masonry Walls

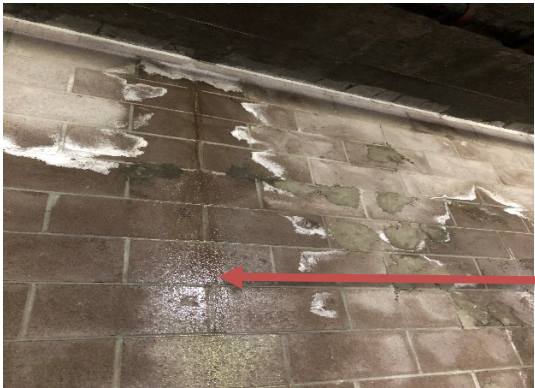
At the time of the observation, water was penetrating the retaining walls of the lower parking area. It was observed that there were several small patches on the surface of the masonry walls that were not leaking. Apparently, there is either no waterproofing behind this wall, or over the years the waterproofing has deteriorated. This will be an area that will require continued maintenance and monitoring. It is not in the scope of this report to provide a repair strategy for this situation. The patches occur on the wall surface and are not considered alterations or modifications to the masonry retaining wall and do not alter the demand nor capacity of the wall.

Fig 13 – Garage Retaining Wall

Water Penetration

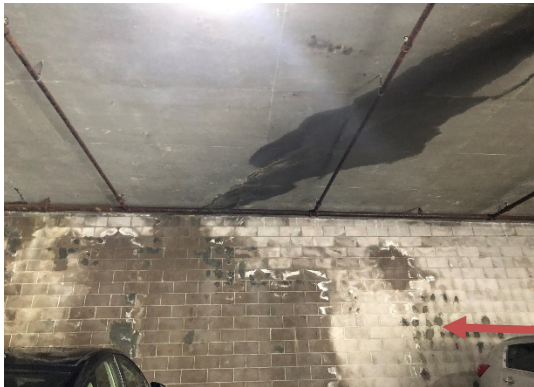
Fig 14 – Retaining Wall Patches

Patches

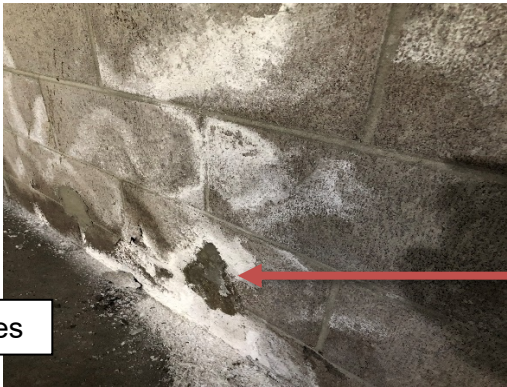
Fig 15 – Retaining Wall Efflorescence

Spalling

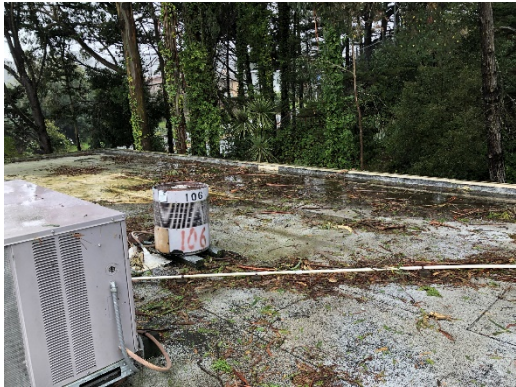
The interior partition walls did not appear to have any vertical nor lateral separations along their supports. The floor and roof framing do not exhibit any excessive deflections. It was noted that there is some ponding on the roof where drainage slopes are shallow, and at cantilevers where long term deflection has likely reduced the original drainage gradient. No structural modifications or alterations were apparent to the floor and roof framing with the exception of the earthquake repair to the floor framing mentioned above.

Fig 16 – Debris and Ponding on Roof

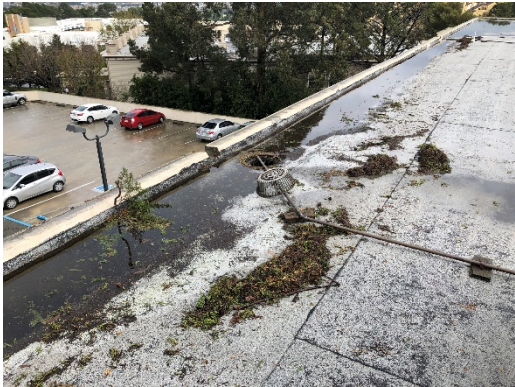
Fig 17 – Debris and Ponding on Roof

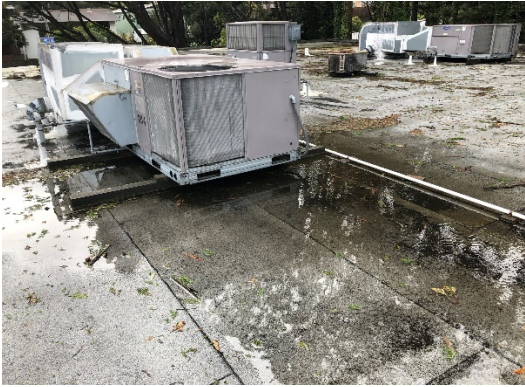
Fig 18 – Sleepers Across Roof Drainage

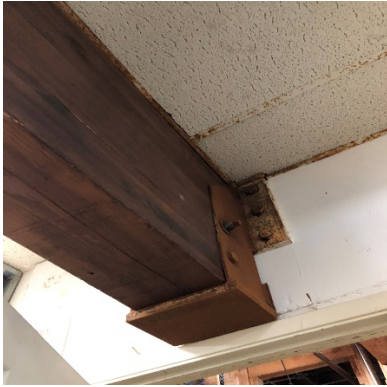
It is reported that the glu-lam beam and steel column repair under the main floor in the east wing was a response to damage that occurred during the 1989 Loma Prieta earthquake. It appears that a stud bearing wall supporting a portion of 2nd floor framing and roof framing over the east wing shown on the framing plans was not built with adequate bearing support in the basement area. The repair has stabilized this area and there is no apparent deflection in the area. The modification is nearly thirty years old and is in good condition.

Fig 19 – Retrofit Beam

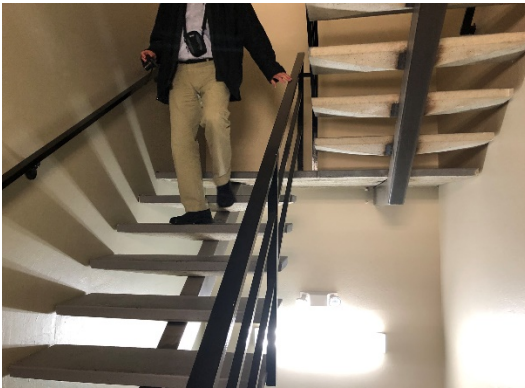
Fig 20 – Main Stairs

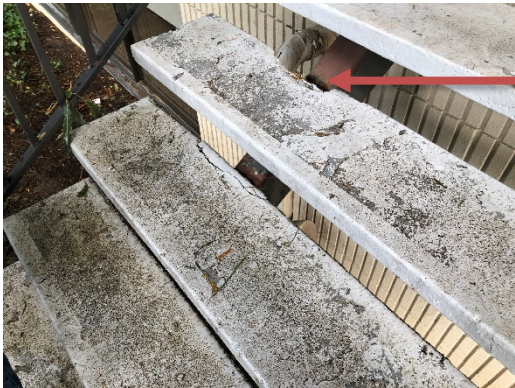
29. The interior stairs, as noted above, are in good structural condition. The exterior stairs appear to be in satisfactory condition with the exception noted in item number 25 above that some spalling is occurring on some concrete treads and maintenance may be required to patch or replace treads with broken pieces. Also note the north stairs land directly onto the parking deck and may need attention regarding egress conditions.

Spalling

Fig 21 – Spalling of Exterior Stairs

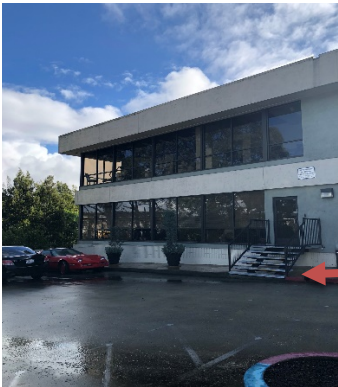
Note
Exiting onto
Deck

Fig 22 – North Exit Stairs

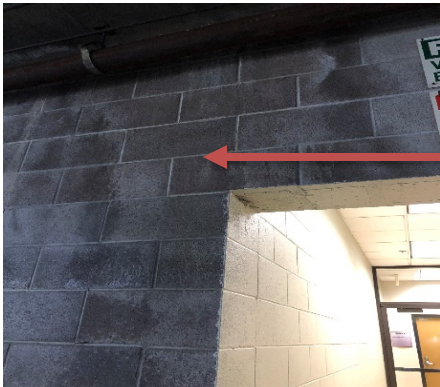
No Signs of
Cracks

Fig 23 –No Diagonal Cracks in Masonry

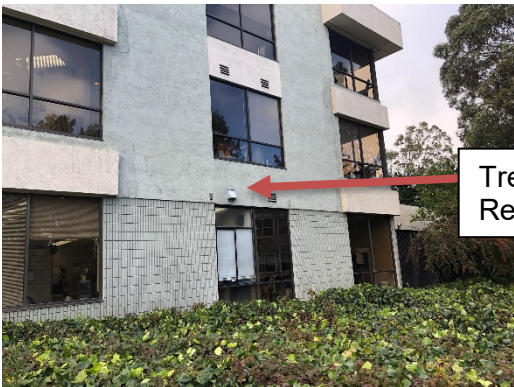
Trellis
Removed

Fig 24 – Stucco and Masonry Walls

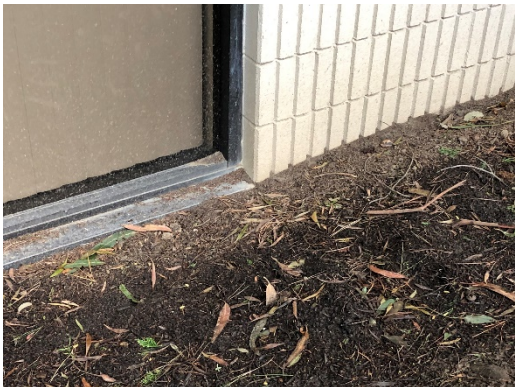
25. Maintenance will become important with respect to both the lower parking retaining wall water proofing as mentioned above, and proper roof drainage. The roof drains must be kept clear of debris from the adjacent trees, and it is suggested to review the timber sleepers under some of the mechanical units for orientation which obstructs drainage. Additionally, some of the concrete on the west side exterior stair treads have spalled off and it is suggested to repair those treads. Dirt was observed close to the main floor windows on the west side of the building. It is recommended to lower the grade away from these windows on the west side to prevent any possible water penetration through the window frames (fig 25).

Fig 25 – Dirt at Foundation Window
