**ASCE 41 Tier 1 Seismic Evaluation
Municipal Services Building
South San Francisco, California**

FINAL REPORT

Prepared For:
City of South San Francisco
315 Maple Ave
South San Francisco, California

April 23, 2025

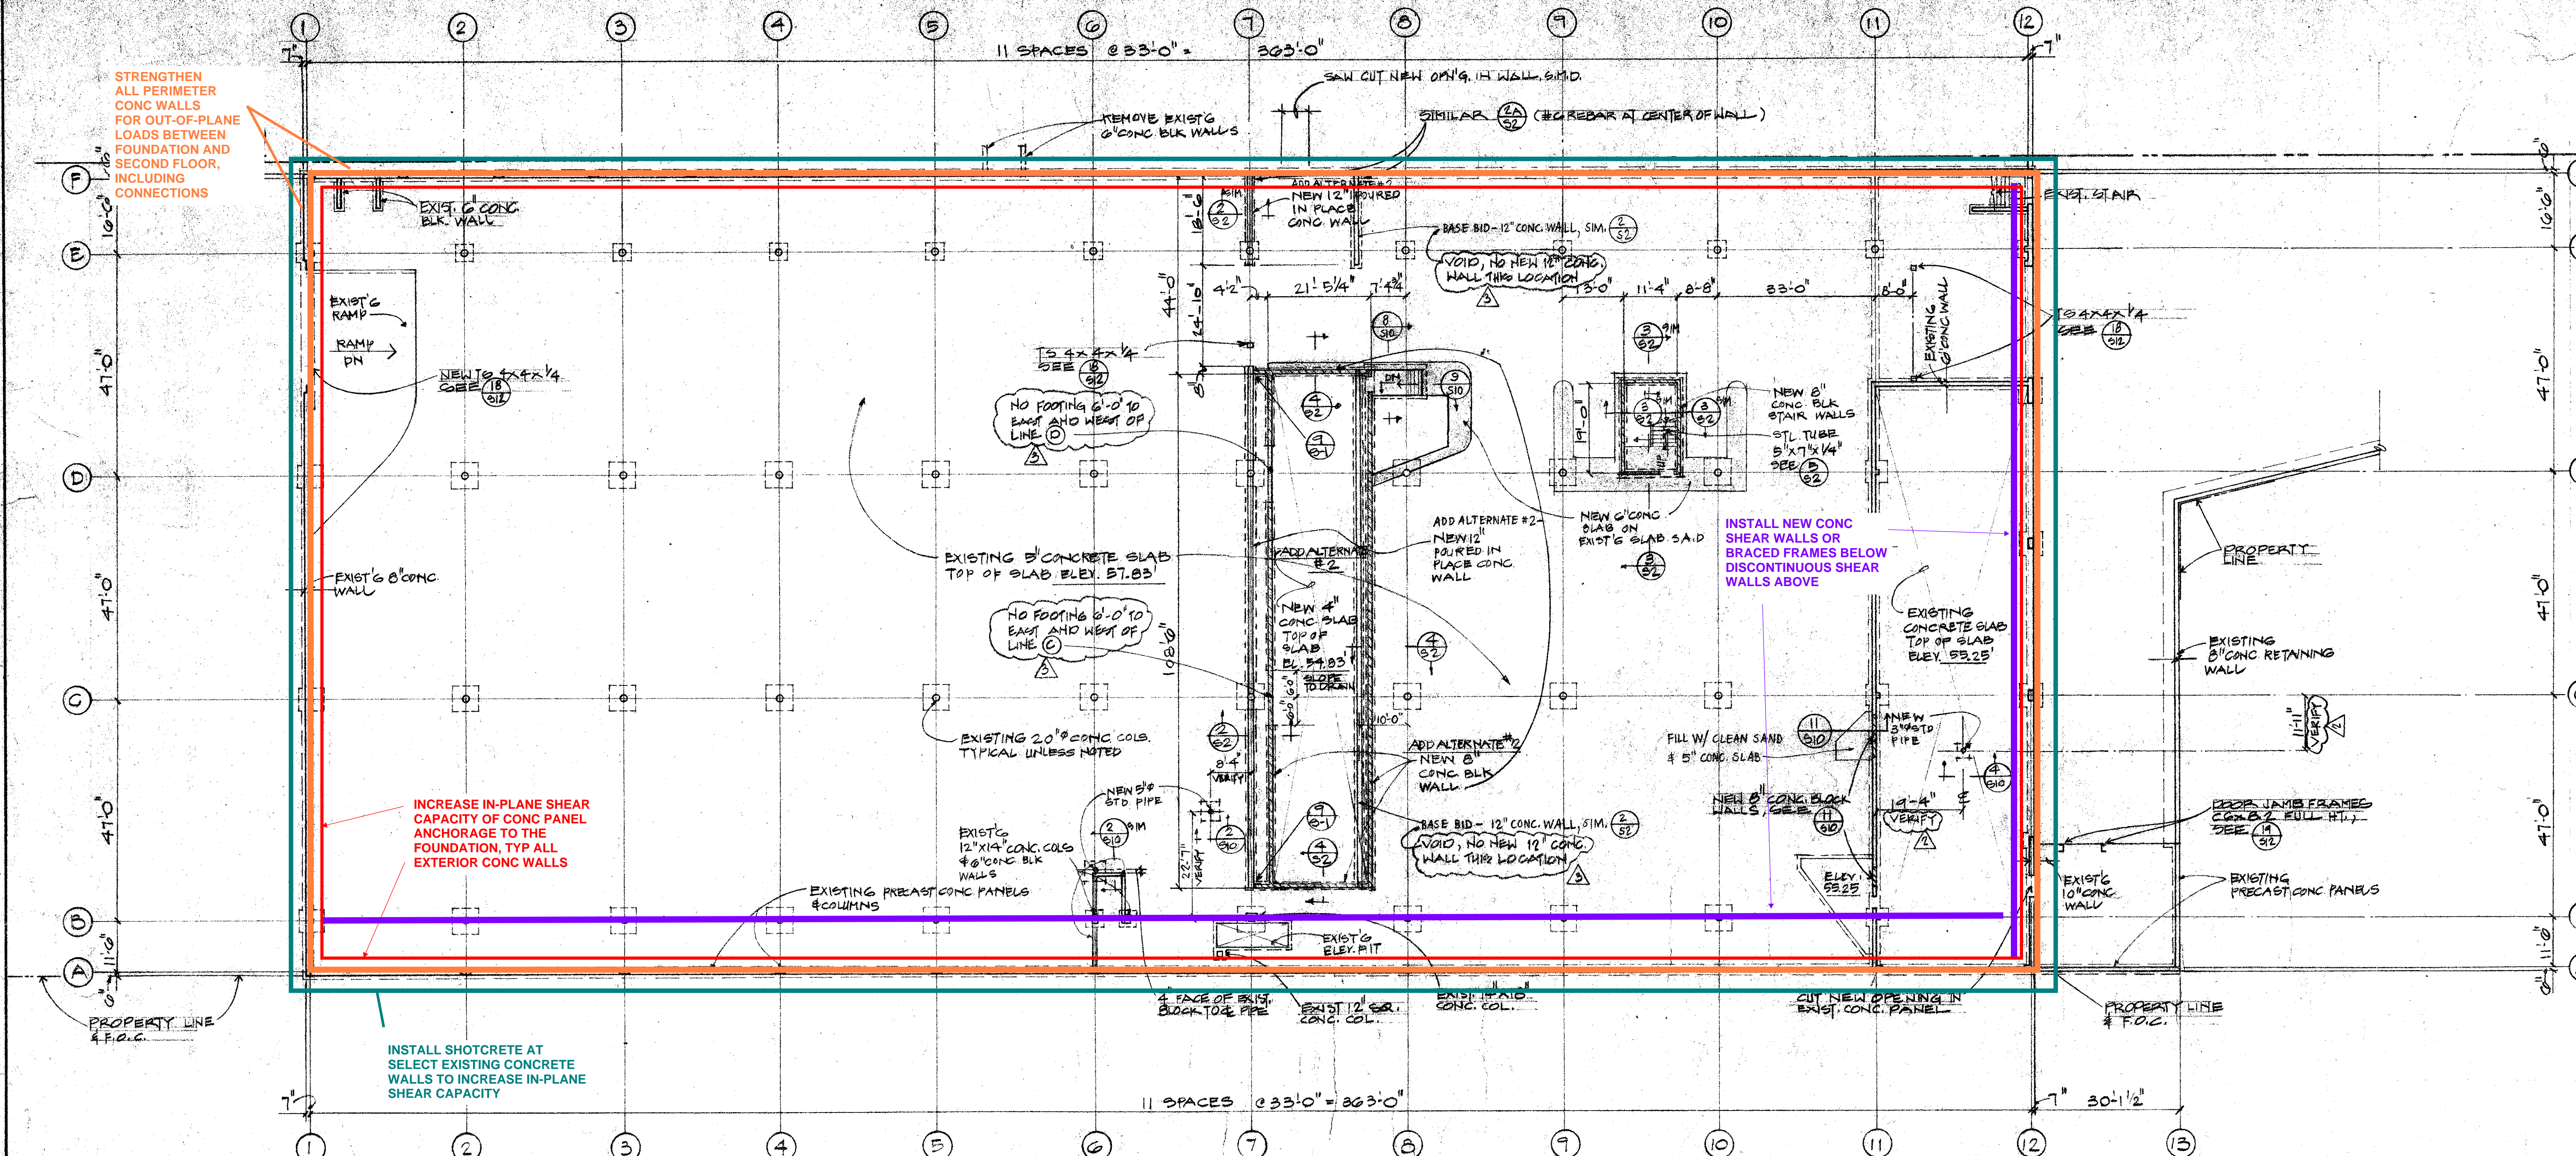
FOUNDATION PLAN
1/8" = 1'-0"

- **FOUNDATION DOWELS:** Wall reinforcement is anchored to the foundation with welded embed plates. ASCE 41 requires concrete walls to be doweled into the foundation with vertical bars equal in size and spacing to the vertical wall reinforcing directly above the foundation.

6. Increase capacity of exterior concrete wall anchorage to the foundations and second floor, both for shear and out-of-plane loads.
7. Strengthen the exterior concrete walls at both stories for out-of-plane loads by adding steel framing attached to the walls or by adding carbon fiber to both wall faces.
