## Arborist Report

120, 130 E Grand Ave/129, 140, 160, 180 Sylvester Rd  
South San Francisco, CA 94080

Inspection Date:  
April 12, 2022

Prepared by: Colin Blackie  
Project Arborist: Colin Blackie/Michael Young

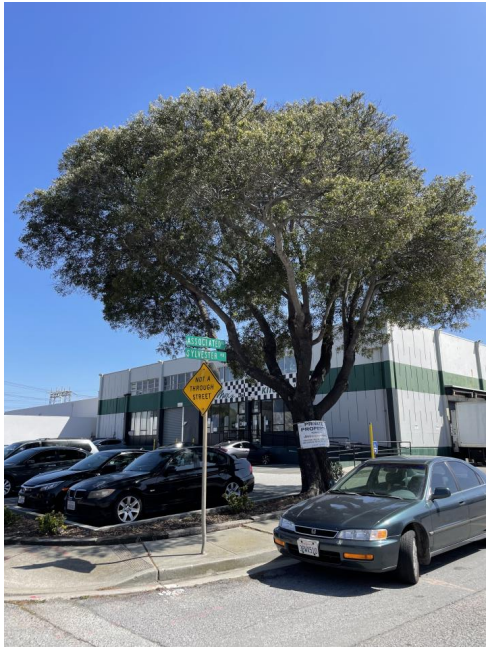
**Tree #50**

| TAG NO. | COMMON NAME | DIAMETER AT BREAST<br>HEIGHT" | H'/W' | HEALTH | STRUCTURE | PROTECTED (X) | TREE DISPOSITION | NOTES, RECOMMENDATIONS |
|---|---|---|---|---|---|---|---|---|
| 50 | Black Acacia | 29 | 35'/30' | f | fp | x | C | DWR, EWR, lots of mechanical damage and wounds, sign bolted to tree, **Consider removal** |

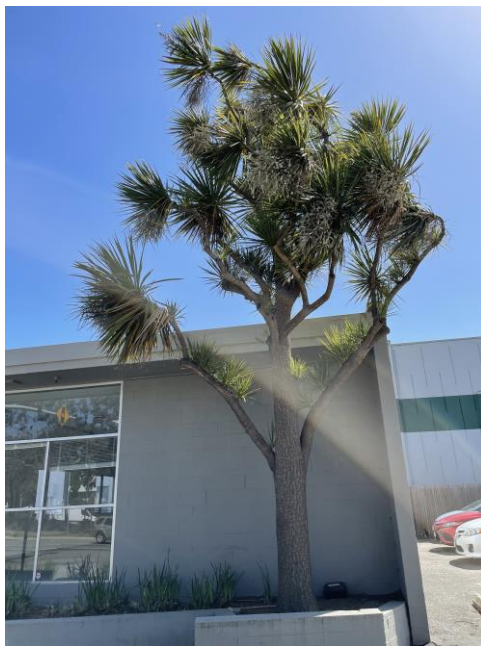
**Tree #51**

| TAG NO. | COMMON NAME | DIAMETER AT BREAST<br>HEIGHT" | H'/W' | HEALTH | STRUCTURE | PROTECTED (X) | TREE DISPOSITION | NOTES, RECOMMENDATIONS |
|---|---|---|---|---|---|---|---|---|
| 51 | Yucca | 14.1 | 25'/12' | f | f | | B | DWR |

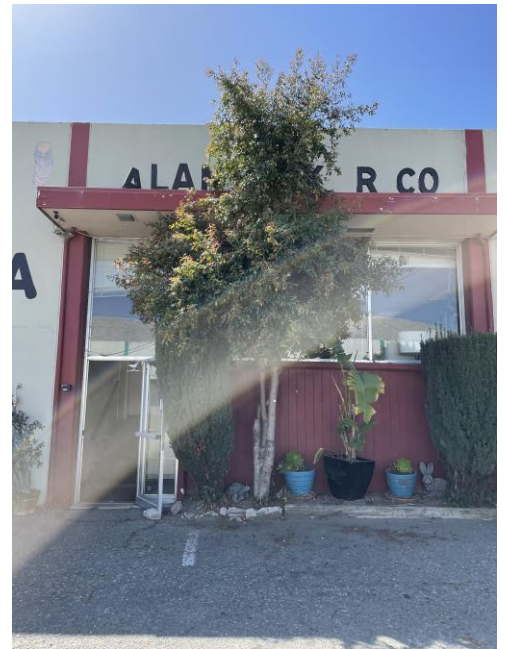
**Tree #53**

| TAG NO. | COMMON NAME | DIAMETER AT BREAST<br>HEIGHT" | H'/W' | HEALTH | STRUCTURE | PROTECTED (X) | TREE DISPOSITION | NOTES, RECOMMENDATIONS |
|---|---|---|---|---|---|---|---|---|
| 53 | Syzigium spp. | 4.2, 3.1, 2.2 | 20'/7' | f | fp | | C | SP, growing against building, CD at base, **Consider removal** |

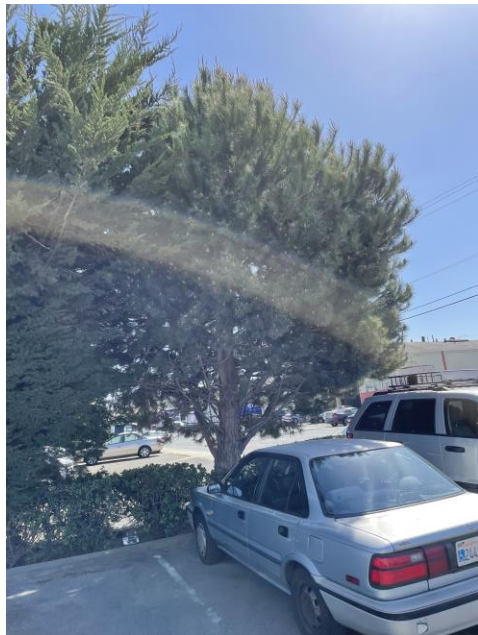
**Tree #54**

| TAG NO. | COMMON NAME | DIAMETER AT BREAST<br>HEIGHT" | H'/W' | HEALTH | STRUCTURE | PROTECTED (X) | TREE DISPOSITION | NOTES, RECOMMENDATIONS |
|---|---|---|---|---|---|---|---|---|
| 54 | Stone Pine | 16.8 at 2' | 22'/13' | fg | fp | x | B | EWR, SP, CD at 7' |

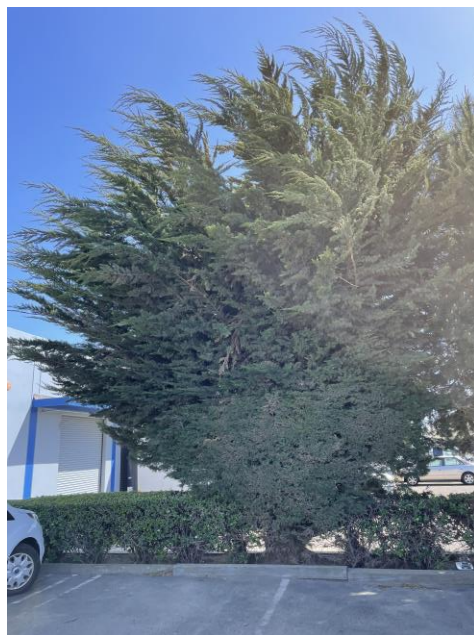
**Tree #55**

| TAG NO. | COMMON NAME | DIAMETER AT BREAST<br>HEIGHT" | H'/W' | HEALTH | STRUCTURE | PROTECTED (X) | TREE DISPOSITION | NOTES, RECOMMENDATIONS |
|---|---|---|---|---|---|---|---|---|
| 55 | Juniper | 22" at 1' above grade | 25' | fg | fp | x | B | SP, CD, large bush splitting at 5' |

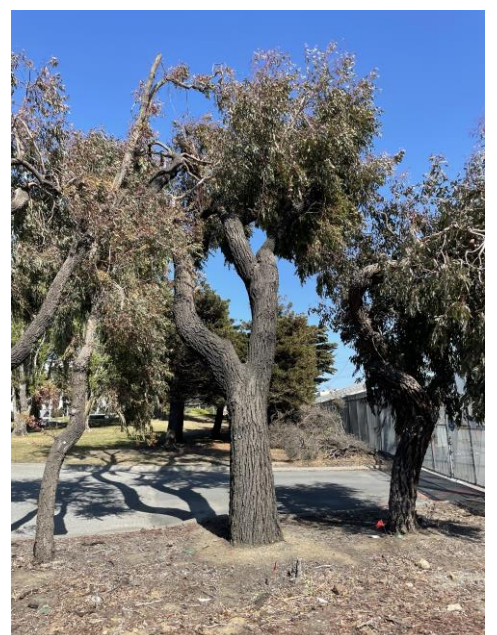
**Tree #60**

| TAG NO. | COMMON NAME | DIAMETER AT BREAST<br>HEIGHT" | H'/W' | HEALTH | STRUCTURE | PROTECTED (X) | TREE DISPOSITION | NOTES, RECOMMENDATIONS |
|---|---|---|---|---|---|---|---|---|
| 60 | Red Ironbark | 23.7 | 30'/30' | f | fp | x | C | lean, extremely unbalanced canopy, CD at 10' |
