ARBORIST REPORT

AGI Avant, INC.

South San Francisco PUC site, existing tree assessment.

November 16, 2018

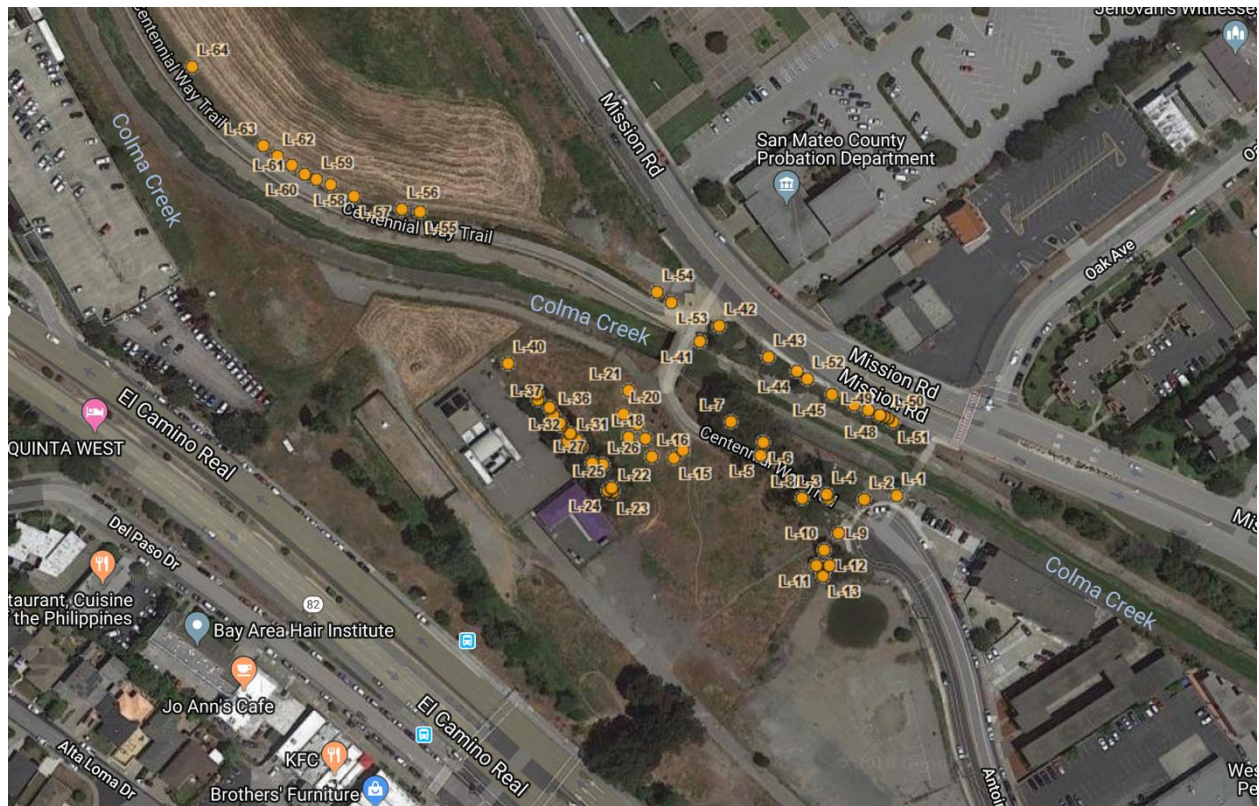
Figure 2: Map of all trees survived.

Of the 64 trees collected 7 trees were recommended for removal either due to being dead, declining or poorly located. 2 trees were slated for structural pruning, that would entail reducing weight on defects seen in the canopy to reduce risk of failure. 26 of the trees were staked or recently planted and showed signs of drought stress with minimal growth and die back present in the canopy.

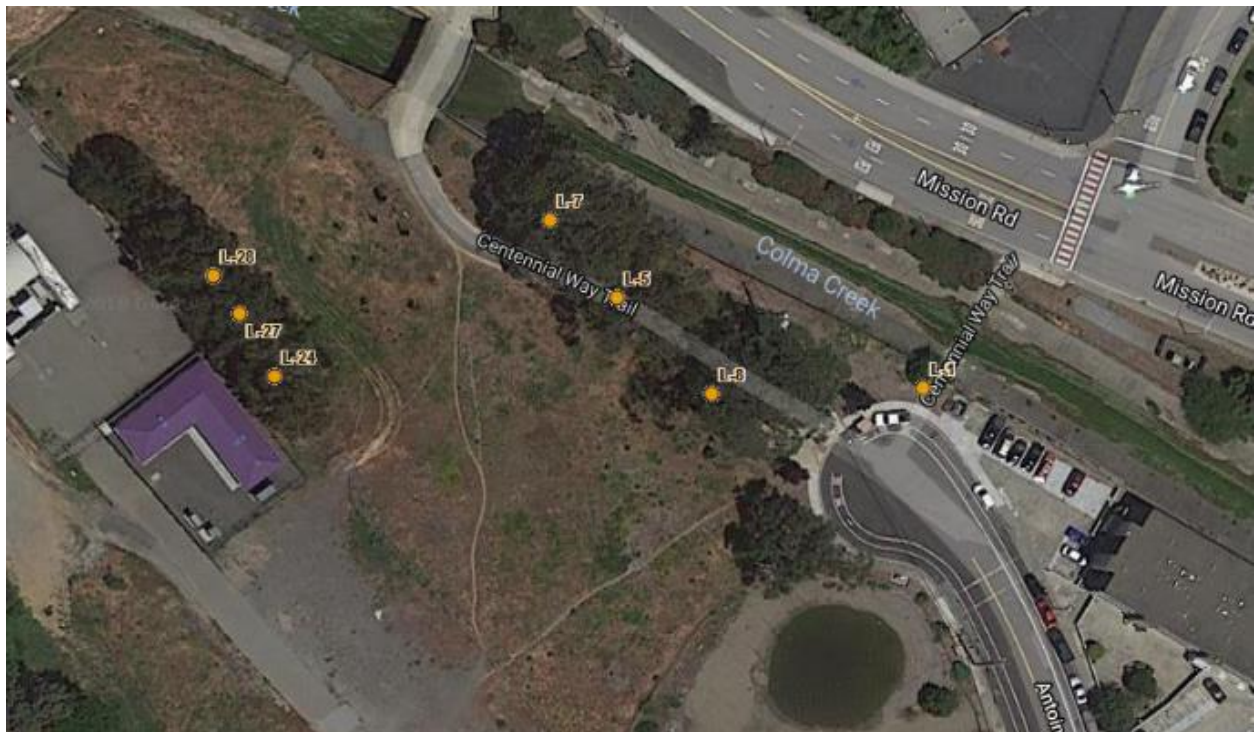
Figure 3: Map of trees that meet the cities protected tree requirements.

The measurements provided by the city for trunk size is provided in circumference, during the assessment the trees were collected by diameter. Multiplying the diameter by 3.14 results in the circumference ($c = d\pi$). 7 trees met the requirement for a removal permit based on size and species listed below.

LOT-1	<i>Hesperocyparis macrocarpa</i> MONTEREY CYPRESS	13-18	17	01-15		Grid/Routine Trim
LOT-5	<i>Eucalyptus globulus</i> BLUE GUM	31+	50	45-60		Trim-Poorly Structured
LOT-7	<i>Eucalyptus globulus</i> BLUE GUM	31+	45	30-45		Trim-Poorly Structured
LOT-8	<i>Eucalyptus globulus</i> BLUE GUM	31+	55	45-60		Grid/Routine Trim
LOT-24	<i>Eucalyptus globulus</i> BLUE GUM	25-30	26	30-45		Grid/Routine Trim
LOT-27	<i>Eucalyptus globulus</i> BLUE GUM	25-30	26	30-45		Grid/Routine Trim
LOT-28	<i>Eucalyptus globulus</i> BLUE GUM	25-30	27	30-45		Grid/Routine Trim
