Arborist Report

500 Railroad Avenue South San Francisco, CA

March 2024

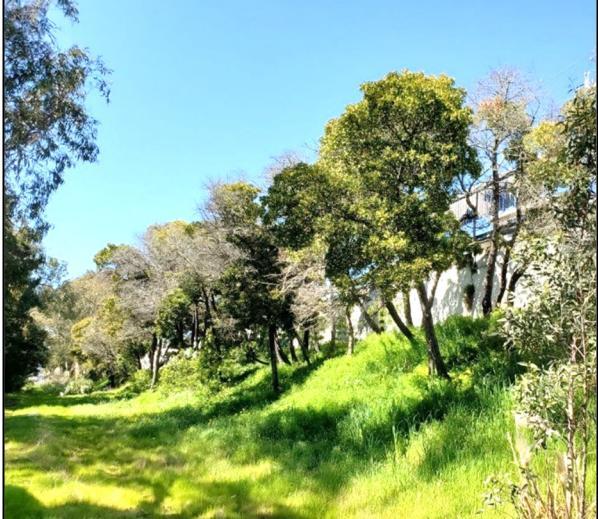
Blackwood acacia was the most frequently occurring species, with 31 trees. Most were growing on the north slope near Railroad Avenue (Photo 1). Condition was almost uniformly poor (30 trees), due to over-crowding and extensive dieback.

Photo 1. Most acacia were growing on a slope below Railroad Avenue.

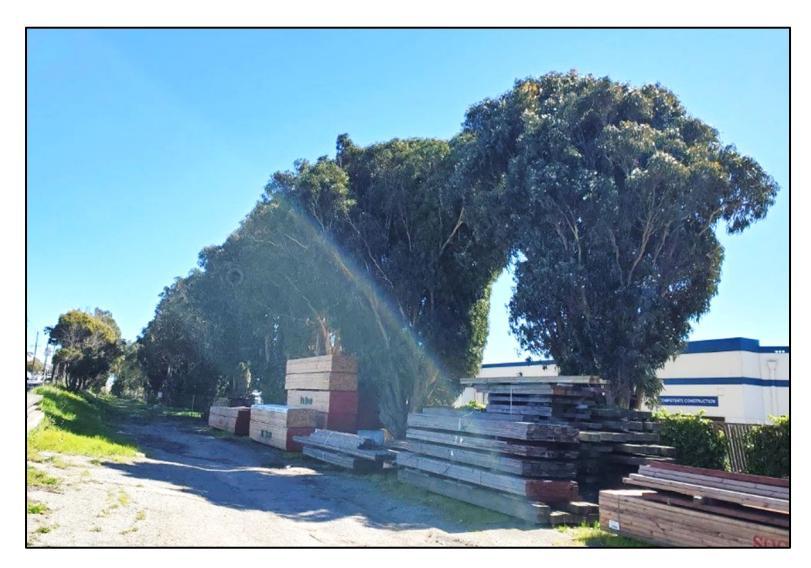
Twenty-one (21) compact blue gums were growing at the edge of the site (Photo 2). Nine were off-site behind a fence on the south side. Most gums (17 trees) were large mature trees in fair condition. Four compact gums were in poor condition due to crowded growing

Photo 2. Compact gums #97 and 98 (at right) were growing at the west end of the property. Gum #98 was off-site behind a fence.

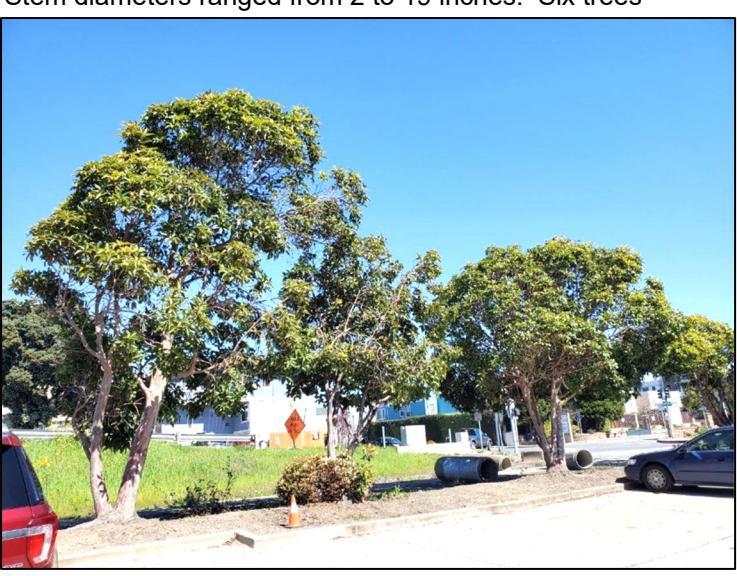
Fifteen (15) Brisbane boxes were in fair (10 trees) or poor condition (5 trees). Several were multi-stemmed at or near the base. Stem diameters ranged from 2 to 19 inches. Six trees were growing off-site (Photo 3).

Photo 3. Brisbane boxes #90, 91 and 92 (L to R) were growing off-site at the southwest edge.

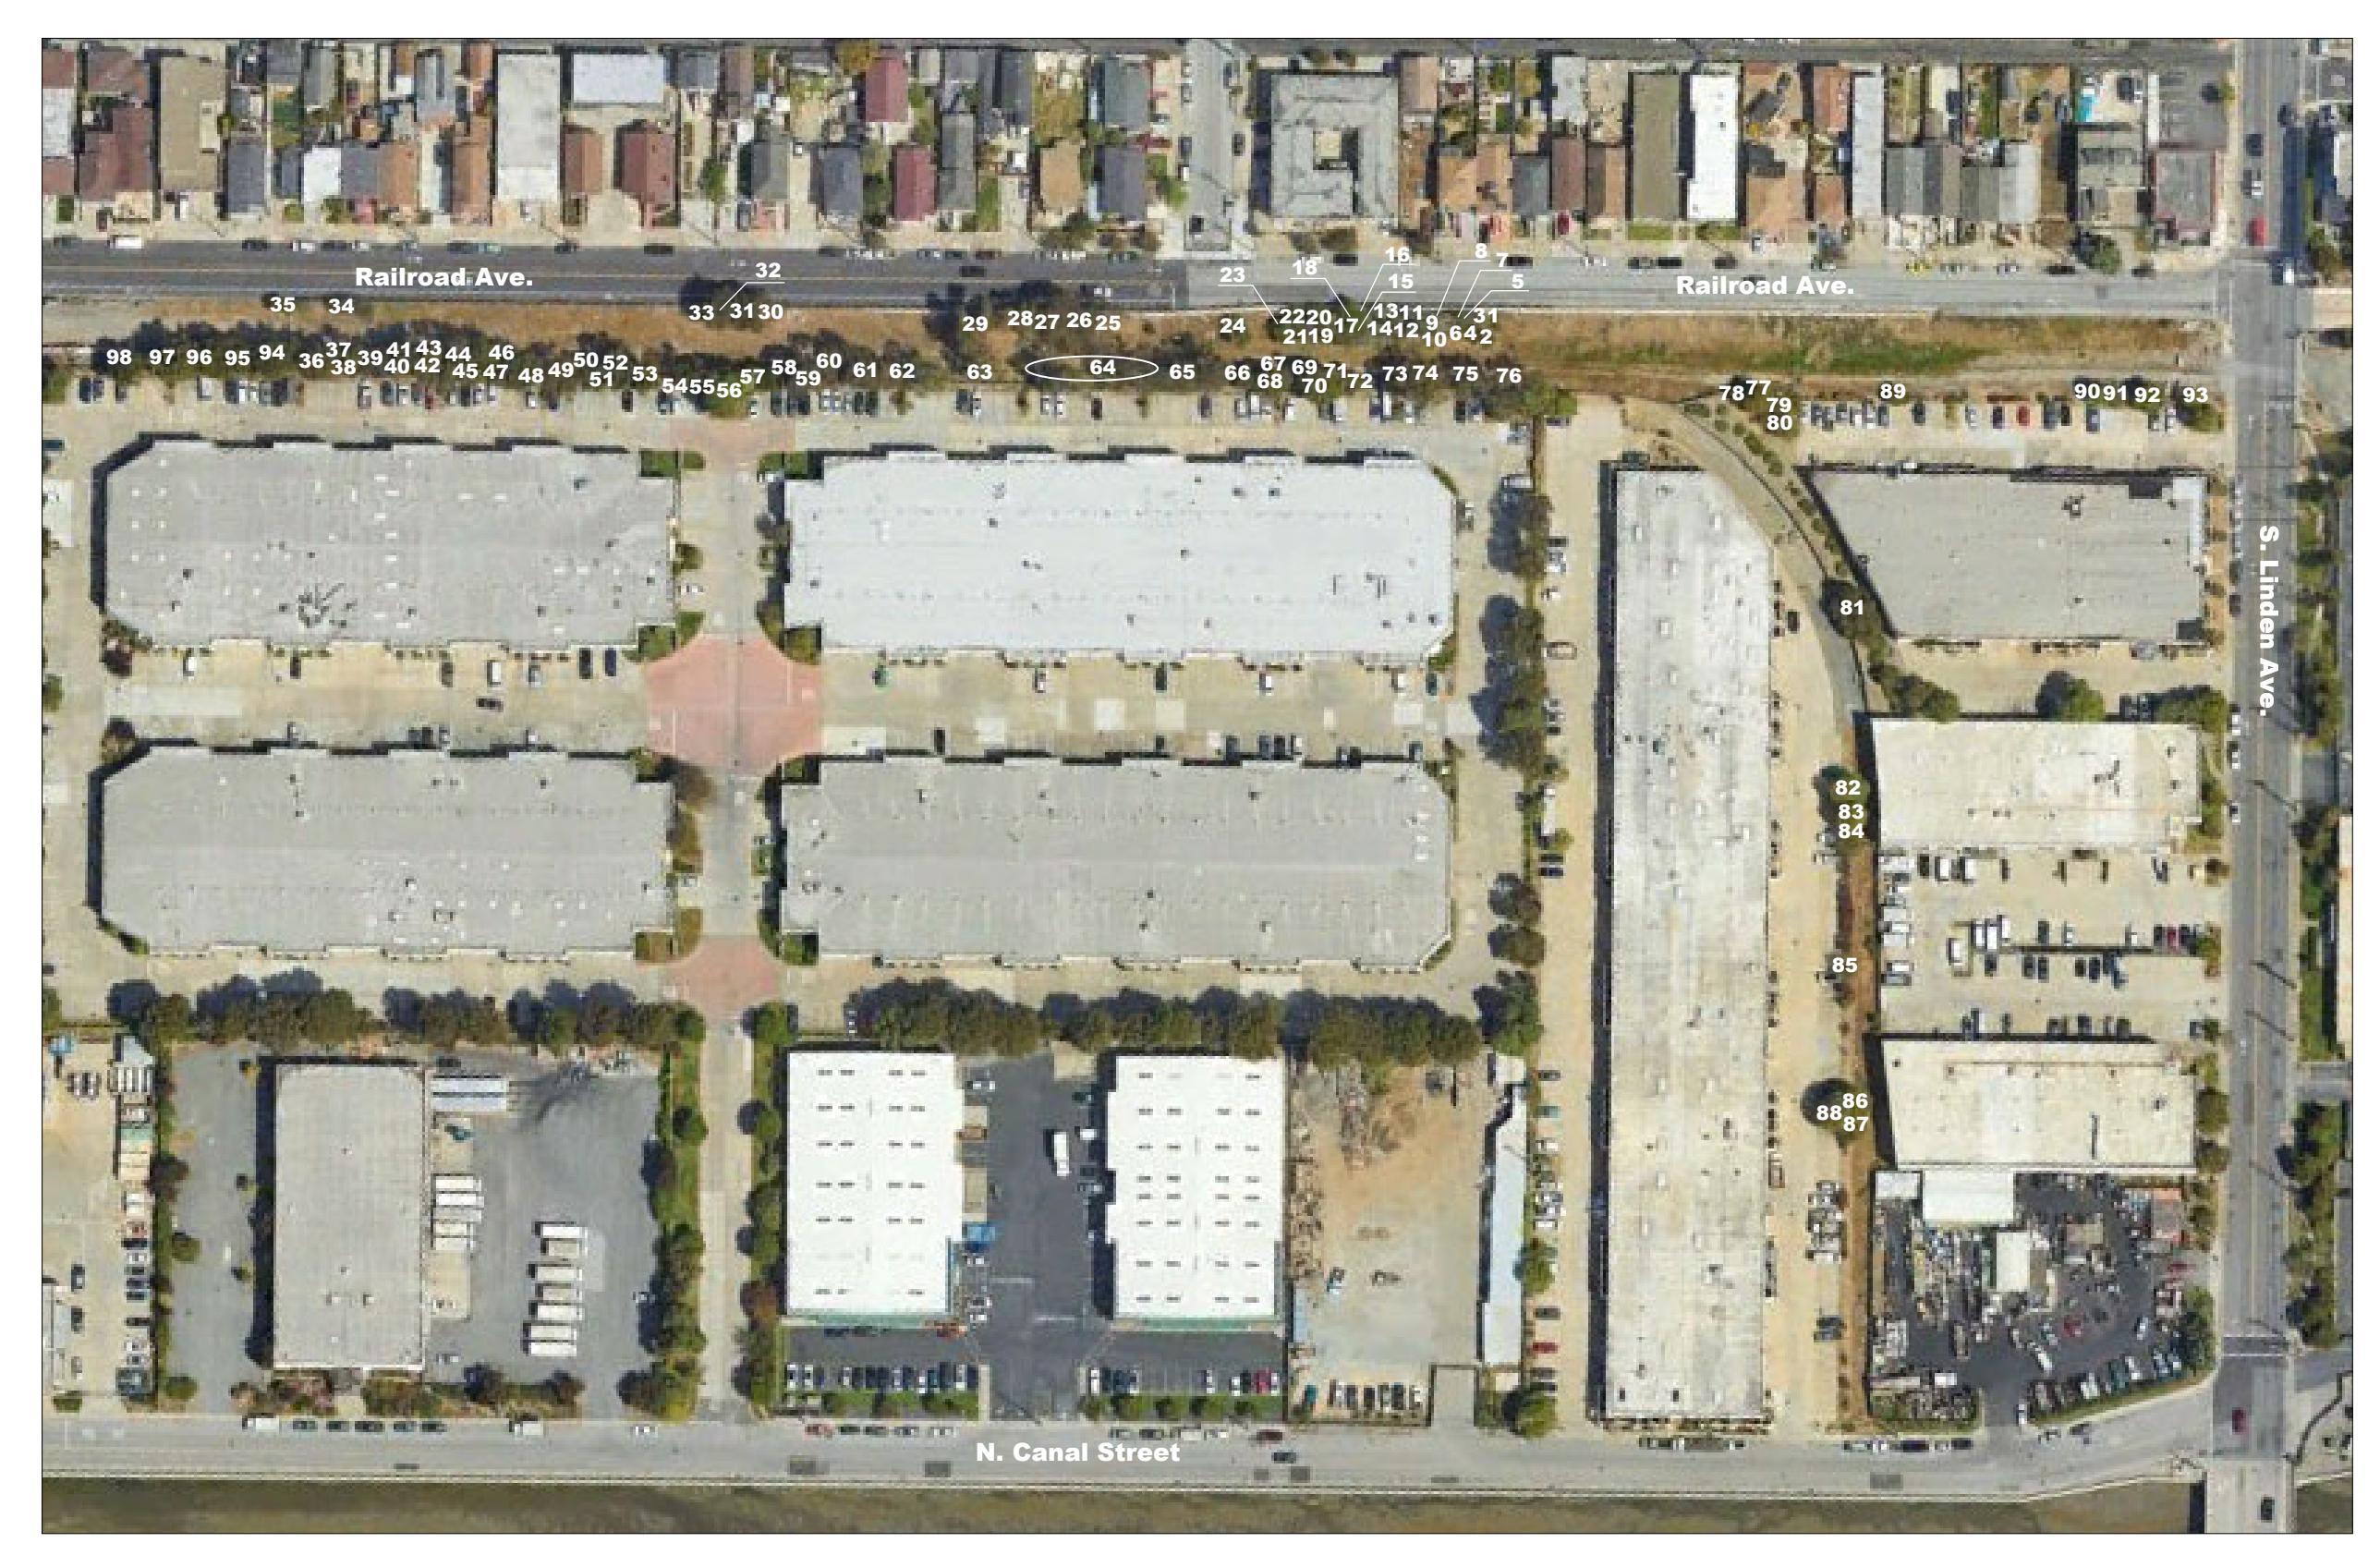
Tree Assessment Map

Numbered tree locations are approximate.
