Appendix A <u>CalEEMod Emissions Calculator Results for Construction-Period Emissions</u> Lamphier-Gregory

Figure 6 Regional Seismic Hazard Zones Map

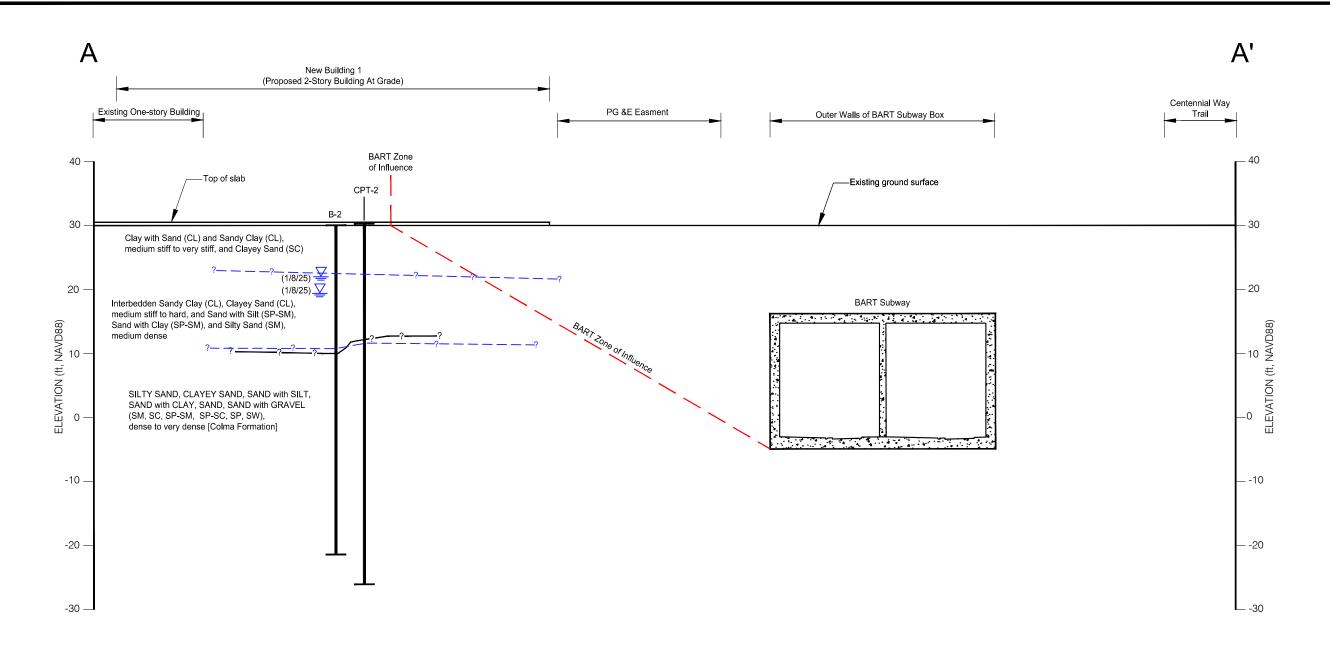
- The above profile represents a generalized subsurface cross section interpreted from widely spaced borings. Soil deposits may vary in type, strength, and other important properties between points of exploration.
- 2. Approximate location of proposed structure is based on site plan provided by Devcon titled "Site Circulation Plan", dated 20 November 2024.
- 3. Approximate location of BART subway box is based on the San Francisco Airport Extension Line as-built drawing titled "San Francisco Airport Extension Line, Trackwork, and Systems, Plan and Profile, W2 357+00 to W2 369+00", provided by San Francisco BART District (2004).
- All elevations referenced herein are based on "Topographic Survey of 201 West Orange Avenue for Hunter Properties Inc., South San Francisco, California", by Kier + Wright, dated March 2004 and reference North American Vertical Datum of 1988 (NAVD88).

Approximate groundwater level measured during drilling

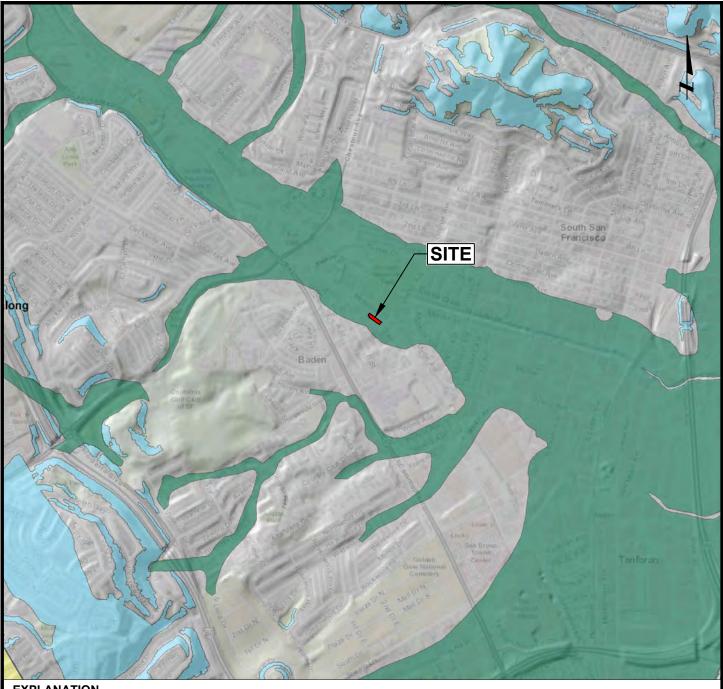
REGIONAL SEISMIC HAZARD ZONES MAP

The site is within a zone designated with the potential for liquefaction, as identified in a map prepared by the California Geologic Survey (formerly known as the California Department of Conservation, Division of Mines and Geology) titled Earthquake Zones of Required Investigation, Seismic Hazard Zones, San Francisco South Quadrangle, Official Map, dated 23 September 2021, as shown on Figure 6. Specifically, the map shows the site is in an area "where historic

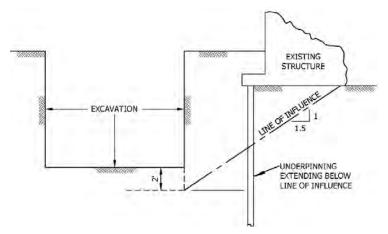
Figure 1: Underpinning Support Requirements

- 5. For structures to be shored for over 5 years, wind loading and design shall be in accordance with applicable codes for permanent structures.
- B. Shoring shall maintain at-rest soil conditions and monitored for movement.

- C. Soil re-distribution caused by temporary shoring or existing foundation system shall be analyzed.
- D. Shoring support shall extend at least 10 feet below the base of the excavation or into a competent soil or rock layer, whichever is deeper, unless the geotechnical engineer shows that vertical and horizontal support requirements can be developed at less than 10 feet below the excavation depth. The minimum depth of shoring below the excavation depth shall be 2 feet.

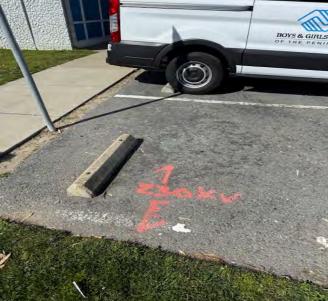
Electrical Line (230 KV) Running Along East of the Existing Building

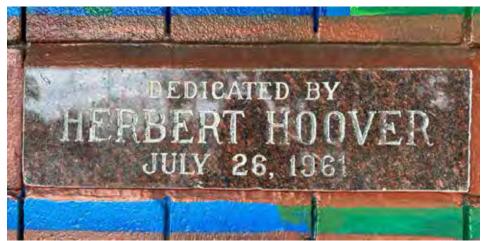
Fig.15 – 201 W. Orange Ave. – Cornerstone
