Final Report

Impact of Utility Cuts on Pavement

City of South San Francisco

April 2025

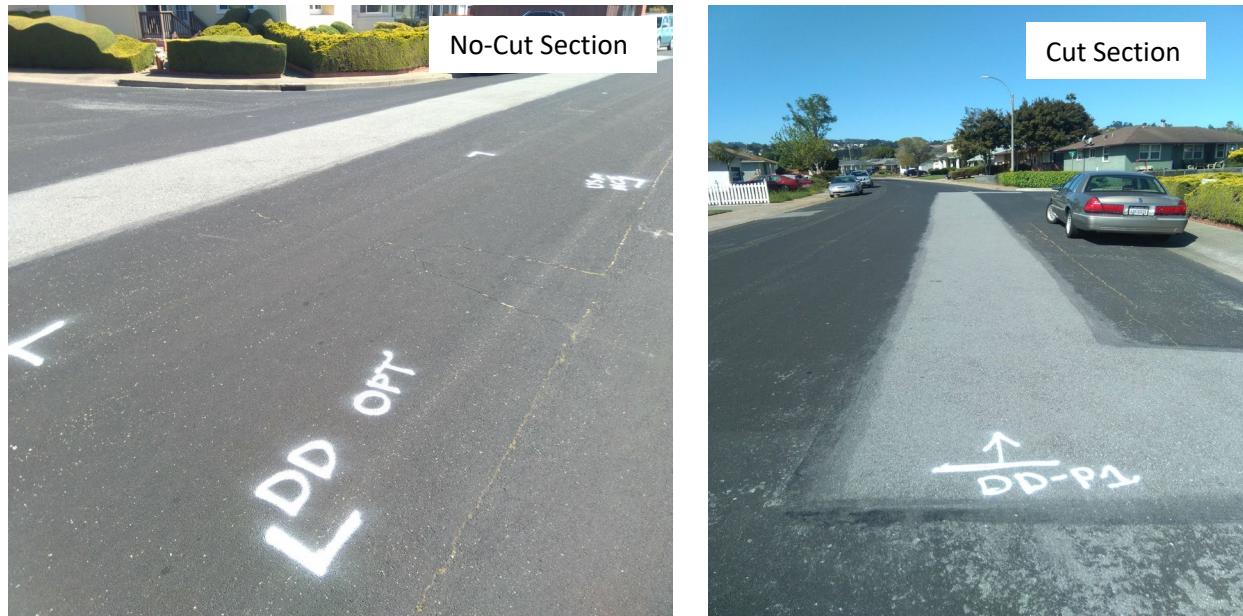
Figure 3. Example Test Site (Del Paso Drive)

Functional and structural field data were collected at 24 test sites throughout the City. Each test site included a section with a utility cut (cut section) and an adjacent section without a utility cut (no-cut section) (Figure 3). The cut and no-cut sections were typically each 100 feet long and at least 1 lane wide. NCE selected adjacent sections to maximize the likelihood that each pair had the same pavement structure and experienced the same loads and environmental conditions.

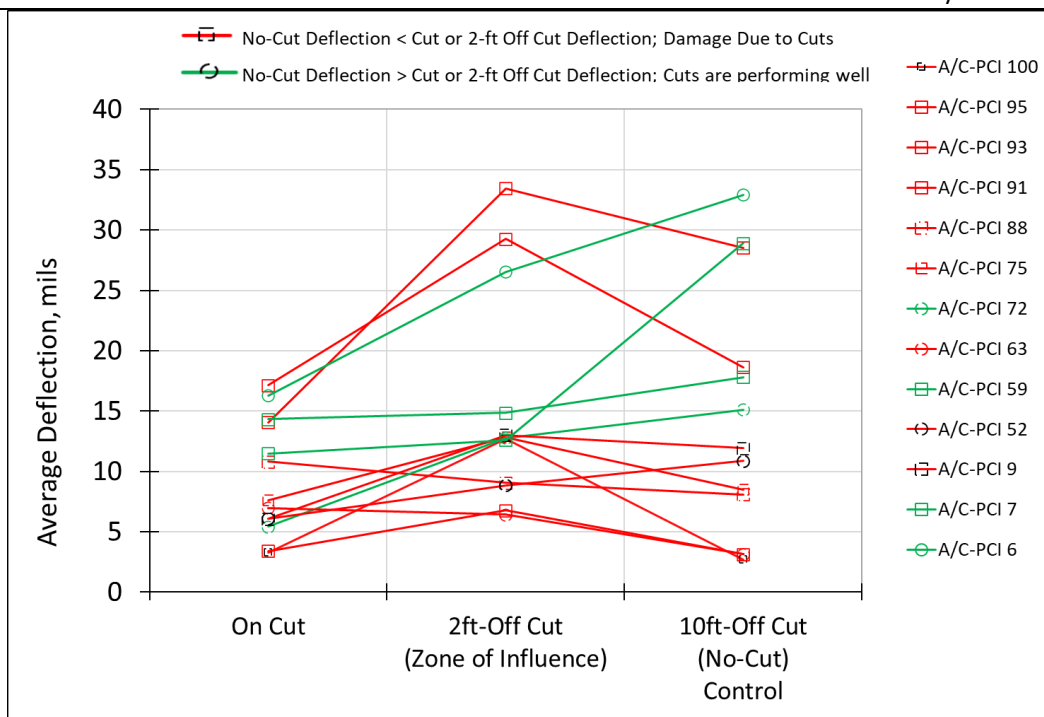
Figure 9. Deflection Trends Organized by PCI of Sections Without Utility Cuts (a) Arterials/Collectors; (b) Residential

Comparing the deflection data across the 3 measurement locations quantifies the relative loss of structural capacity resulting from utility cuts. Figure 9 shows the average deflections for each test site organized by the PCI of the site's no-cut section. Sections that exhibited damage due to cuts are represented by red lines. Green lines denote the opposite i.e. deflection of no-cut sections was actually higher than the cut section or zone of influence. This is an indication that the cut repairs/restoration were performing well at the time of testing. Note that the deflections at the "Zone of Influence" could be higher than on cuts because of the slumping effect as explained under Section 1.2.

Based on the deflection data, 66.7% of test sites showed structural damage in the cut or zone of influence (red lines in Figure 9 and red bars in Figure 10) while the remaining 33.3% showed a structural improvement in the cut and zone of influence relative to the section with no utility cut (green lines in Figure 9 and blue bars in Figure 10).

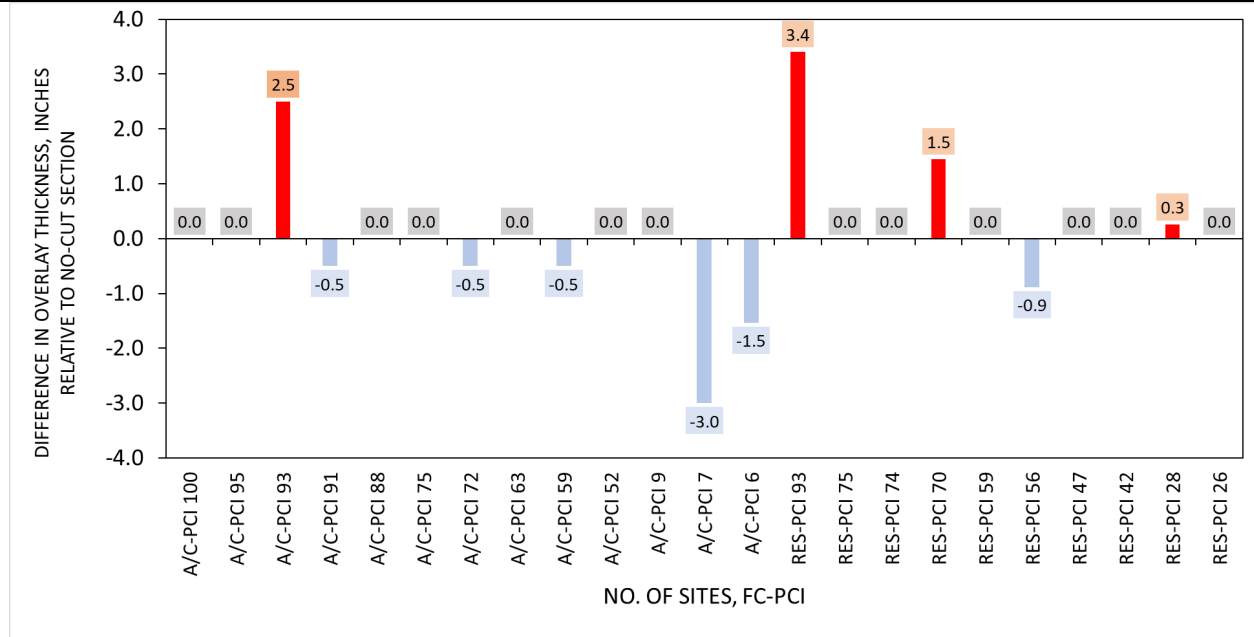
Figure 12. Differences in Overlay Thickness

Figure 12 summarizes the differences in overlay thickness between the no-cut sections and the thickest overlay in either cut sections or the zones of influence for all test sites. The data are organized by the PCIs of the no-cut sections. The x-axis shows the functional class associated with PCIs of the no-cut sections, ranging from high to low.

Consequently, even though 66.7% of the sites exhibited structural damage based on deflection, the substantial *in-situ* pavement thickness and the 4-inch restoration layer in the cut area meant that only a few sites required a thicker overlay to address structural deficiencies. Of the 24 sites assessed, only 16.7% (4 sites) will require an additional overlay of approximately 2.5 inches within the cut section or its zone of influence to restore structural capacity.

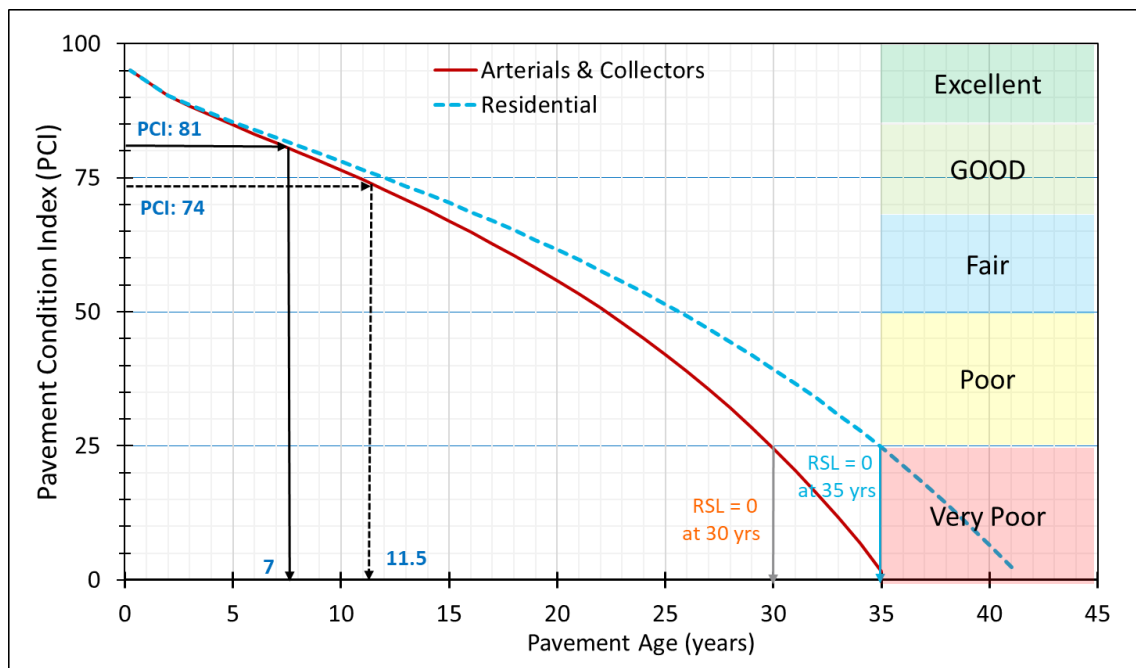
Figure 14. Pavement Family Deterioration Curves for Streets in the City

The percent reduction in pavement service life due to utility cuts was estimated using the StreetSaver® family deterioration curves for asphalt concrete pavement sections (Figure 14). For example, assume an arterial/collector with no cut has a PCI of 81. A PCI of 81 for arterials/collectors corresponds to an equivalent service life of 7 years (solid black arrows in Figure 14). Based on the analysis in the previous section, a large cut would reduce the PCI to 74, which corresponds to an equivalent service life of 11.5 years (dashed black arrows in Figure 14). Consequently, the cut in this example reduces the pavement service life by 4.5 years, or 15% of its 30-year service life.

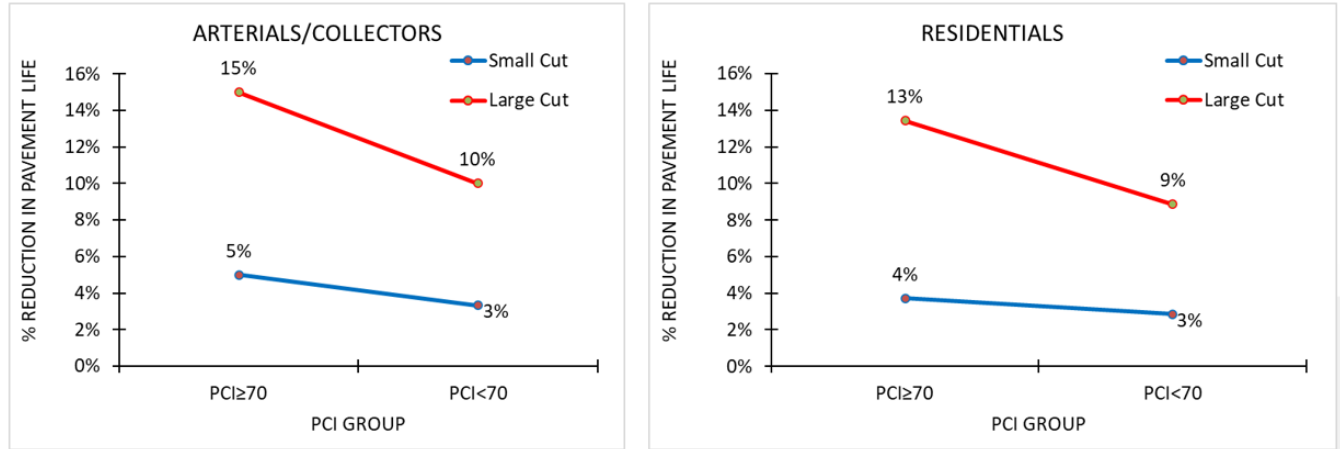
Figure 15. Percent Reduction in Pavement Service Life

The above calculation was performed for both arterials/collectors and residential in all PCI groups and for all cut sizes to estimate the percent reduction in pavement service life (Figure 15).
