Phase I Environmental Site Assessment

Former Railroad Tracks
Railroad Avenue between S. Linden Avenue and S. Spruce Avenue
South San Francisco, California 95014

April 10, 2024

PSI Project Number: 0575-2660

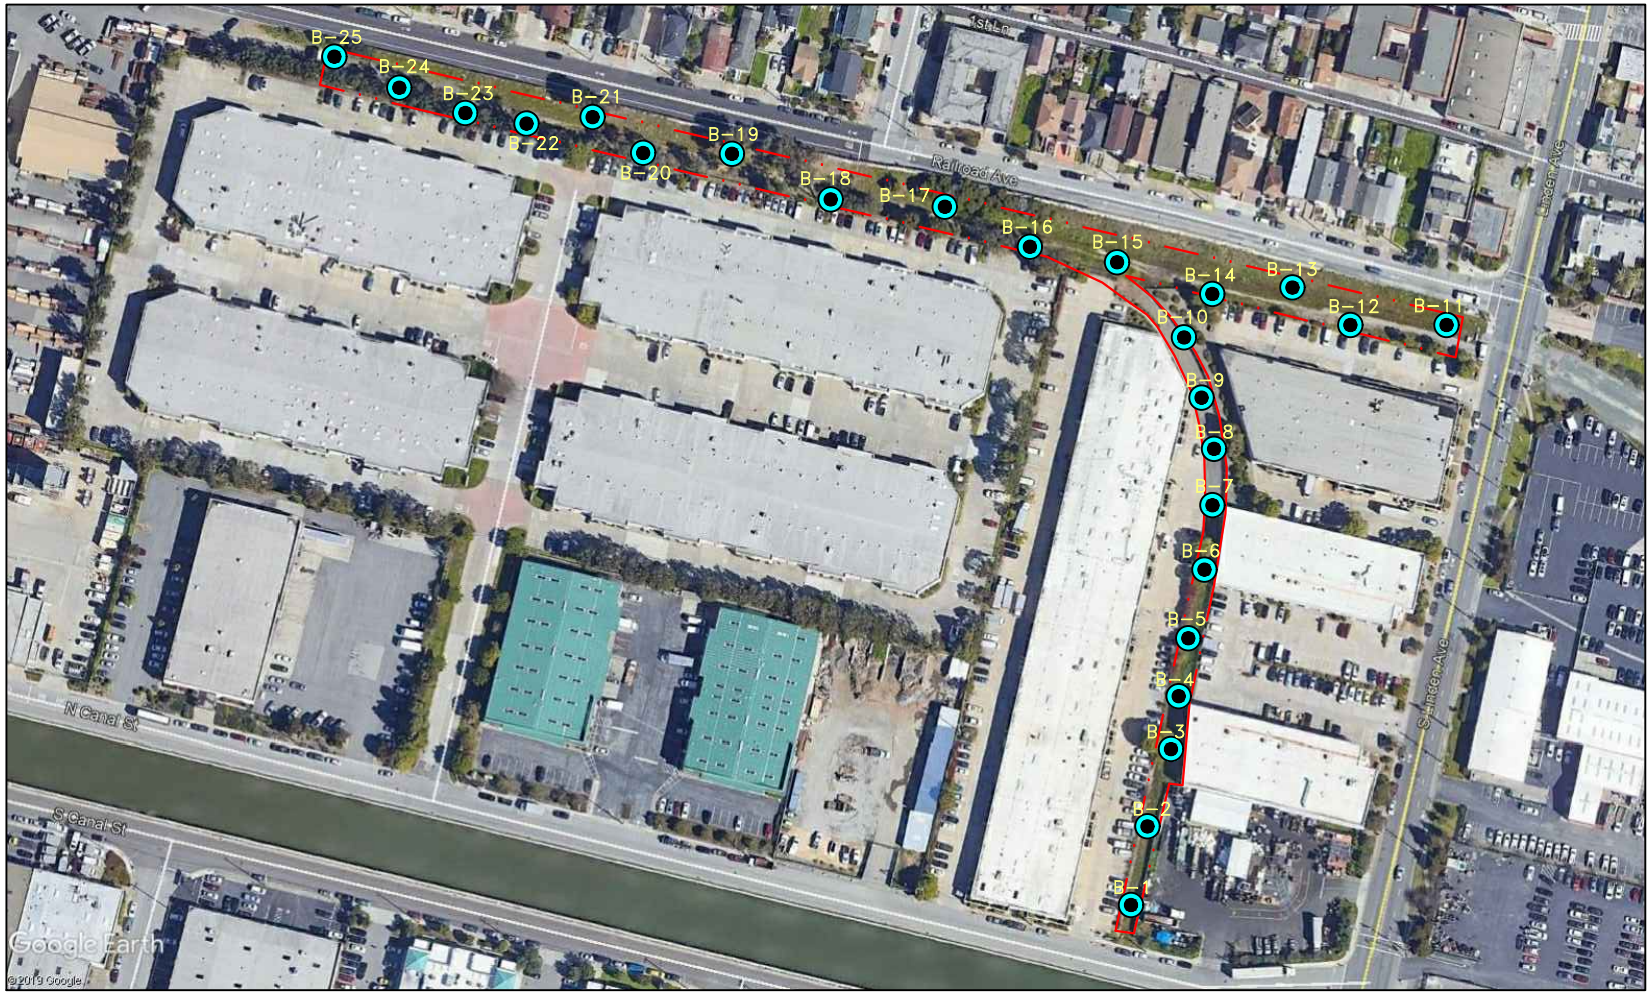
Project Name:	Drawn By:	Date:	File No.:	Figure No.:
ENVIRONMENTAL INVESTIGATION RAILROAD AVENUE AND LINDEN AVENUE, SOUTH SAN FRANCISCO, CALIFORNIA	Z.J.	1/20	1604-1-1	1
Title: SITE LOCATION MAP	**Approved By:** F.P.	**Project No.:** 575-1604-1

- Total lead concentrations were found to be above the TTLC and the TCLP waste criteria in one soil sample (B-15-1). The soil represented by this sample would be classified as a Federal RCRA waste upon excavation and classification as a waste material. The soil identified as a Federal RCRA waste appears to be confined to the upper one foot. PSI estimated the volume of Non-RCRA soil to be approximately 160 cubic yards.

- PSI believes further investigation in the area of boring B-15 and borings B-23 through B-25 could reduce the volume of soil that would be considered to be a Federal RCRA or Non-RCRA hazardous waste. This is especially true in the area of B-15, as the one-foot sample with the elevated lead concentrations did not appear to be similar to the rest of the soil found across the subject property.

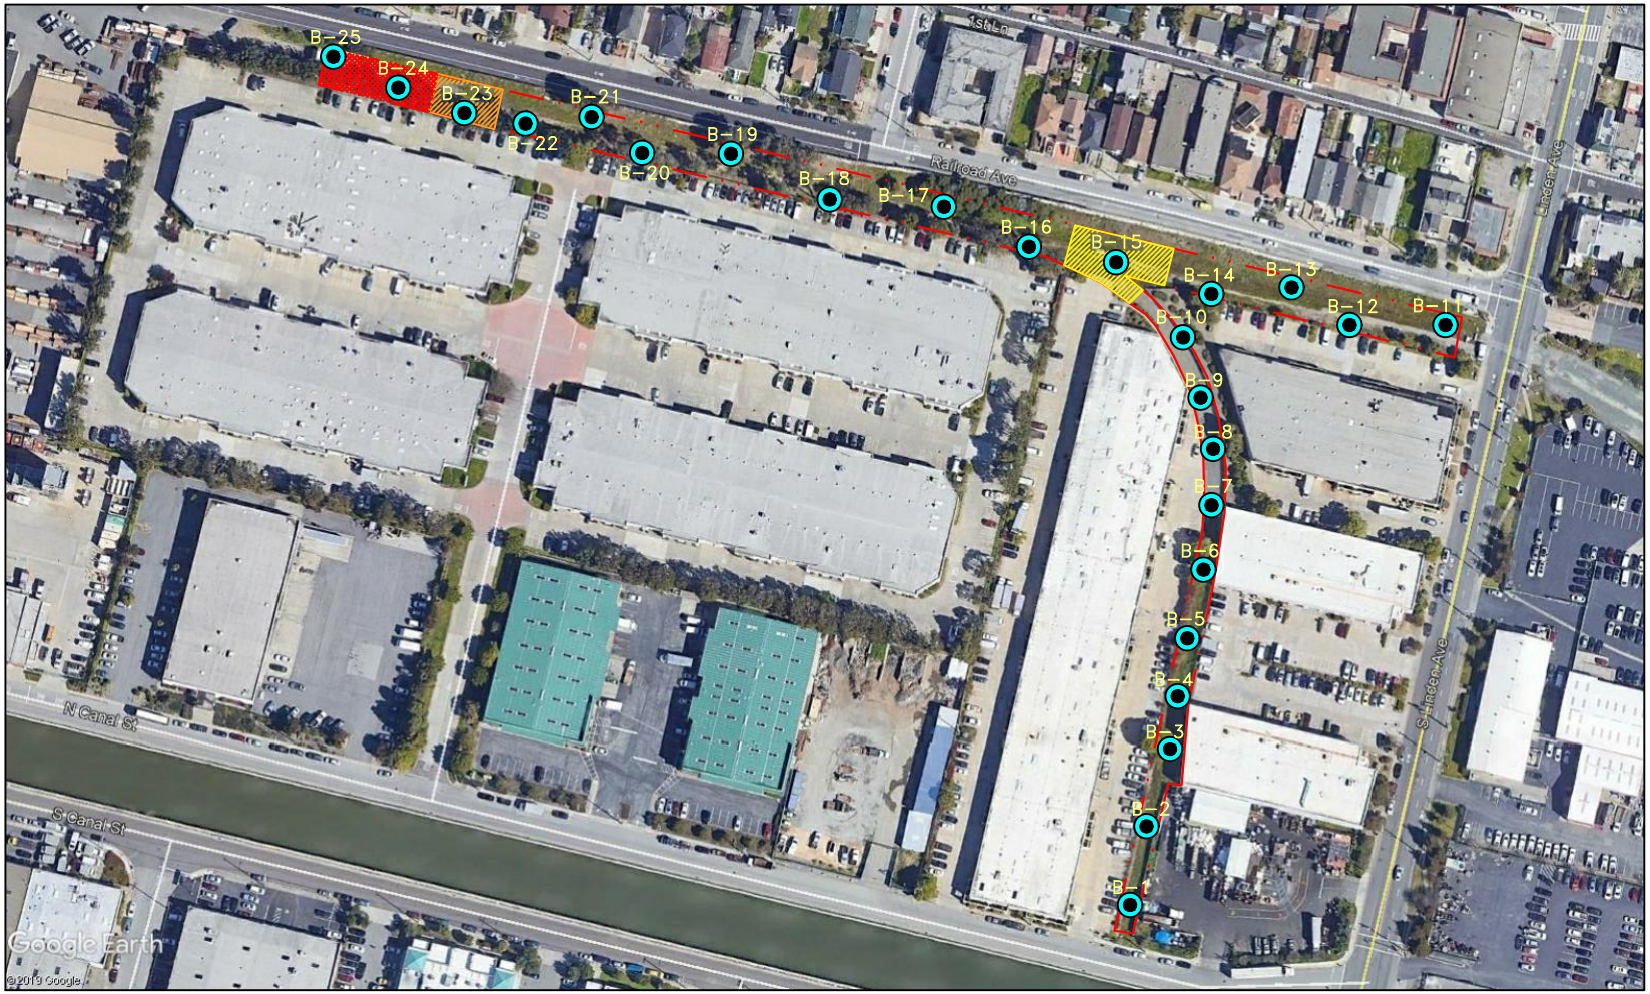
Project Name:	Drawn By:	Date:	File No.:	Figure No.:
ENVIRONMENTAL INVESTIGATION RAILROAD AVENUE AND LINDEN AVENUE, SOUTH SAN FRANCISCO, CALIFORNIA	Z.J.	1/20	1604-1-2	2
Title: GEOPROBE LOCATION MAP	**Approved By:** F.P.	**Project No.:** 575-1604-1

The contaminant of concern as identified in the analyses of the soil samples at the subject property is lead. Lead concentrations above the California Non-RCRA waste criteria upon excavation and classification as a waste material were found in soil samples B-23-1, B-24-1, B-24-2, B-25-1, and B-25-2. These elevated lead concentrations were found in borings B-23 through B-25 on the far western end of the subject property. The 4-foot samples collected in each of these borings did not have elevated lead concentrations, while the 2-foot sample collected in boring B-23 did not have elevated lead concentrations. The soil identified as a Non-RCRA waste appears to be confined to the upper two feet on the far western portion of the subject property. Figure 3 depicts the area of lead-impacted Non-RCRA soil. PSI estimated the volume of Non-RCRA soil to be removed using a bulking factor of 1.2. The volume of Non-RCRA soil was estimated to be approximately 425 cubic yards.

Lead concentrations above the Federal RCRA Waste criteria upon excavation and classification as a waste material were found only in soil sample B-15-1. The 2 and 4-foot samples collected from this boring did not have elevated lead concentrations. The soil identified as a Federal RCRA waste appears to be confined to the upper one foot in this area of the subject property. Figure 3 depicts the area of lead-impacted Federal RCRA soil. PSI estimated the volume of Federal RCRA soil to be removed using a bulking factor of 1.2. The volume of Federal RCRA soil was estimated to be approximately 160 cubic yards.

Further investigation in the area of boring B-15 and borings B-23 through B-25 could reduce the volume of soil that would be considered to be a Federal RCRA or Non-RCRA hazardous waste. This is especially true in the area of B-15, as the one-foot sample with the elevated lead concentrations did not appear to be similar to the rest of the soil found across the subject property. There is the possibility that the Federal RCRA waste maybe confined to a small area localized around boring B-15

– RCRA HAZARDOUS WASTE SOIL REMOVAL TO 1 FOOT BELOW SURFACE GRADE (160 cubic yards)
