Appendix F:

Hazards and Hazardous Materials Supporting Information

RE: PHASE I EVIRONMENTAL SITE ASSESSMENT 71 CAMARITAS AVENUE, SOUTH SAN FRANCISCO, CA.

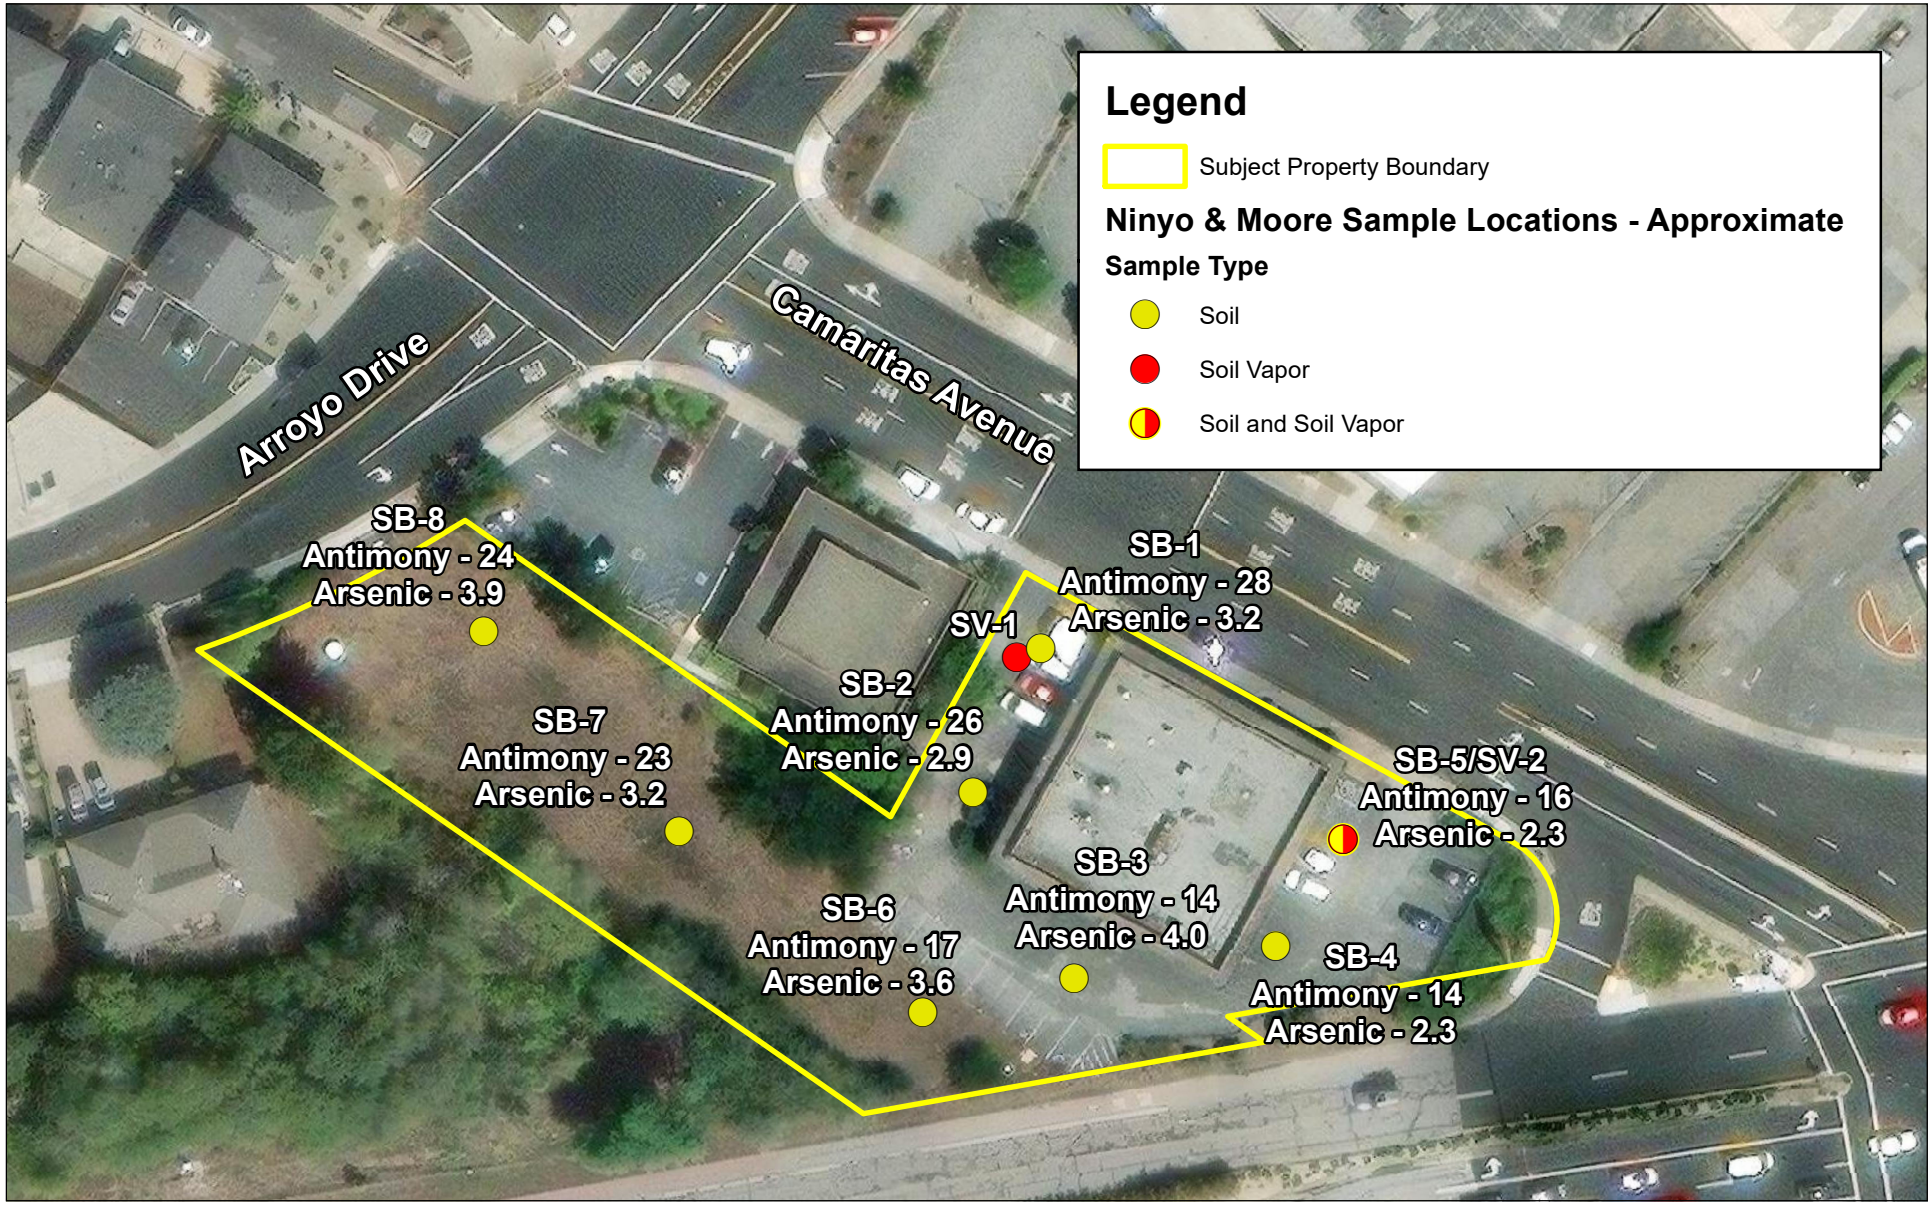
Figure #3

Analysis of two soil gas samples collected by Ninyo & Moore identified chloroform and benzene in one sample above their respective residential screening levels. In the Ninyo & Moore report, these concentrations were compared to the State of California Water Resources Control Board Low-Threat Underground Storage Tank Closure Policy (LTCP). Based on this comparison Ninyo & Moore determined the presence of these compounds in the subsurface of the property constitutes *de minimis* conditions and was unlikely to pose a significant risk to the current building occupants.

Ninyo & Moore Inc. Soil Vapor Results Above ESLs (Results Provided in µg/m³)

Considering the potential for subsurface conditions to change during redevelopment, Cameron-Cole recommends that a limited soil gas sampling event be performed following completion of any demolition and grading activity on the

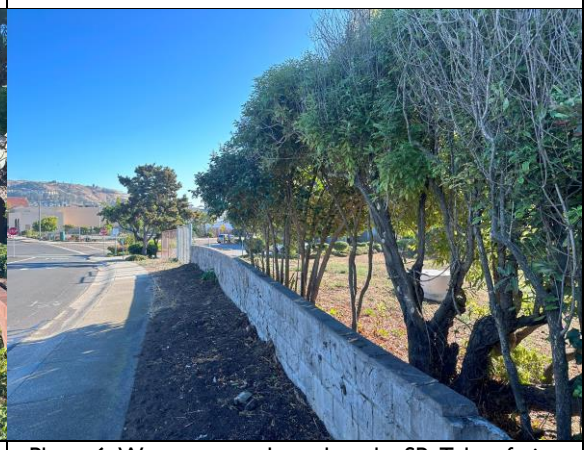
Photo 1: Southeastern face of 71 Camaritas Avenue. Photo taken facing northwest.	Photo 2: Edge of SP along Westborough Boulevard, photo taken facing roughly west.

Photo 3: Boundary of SP along Camaritas Avenue. Photo taken facing northwest.	Photo 4: Rear, loading area of 71 Camaritas avenue. Photo taken facing southeast.
