**ASCE 41 Tier 1 Seismic Evaluation
Municipal Services Building
South San Francisco, California**

FINAL REPORT

Prepared For:
City of South San Francisco
315 Maple Ave
South San Francisco, California

April 23, 2025

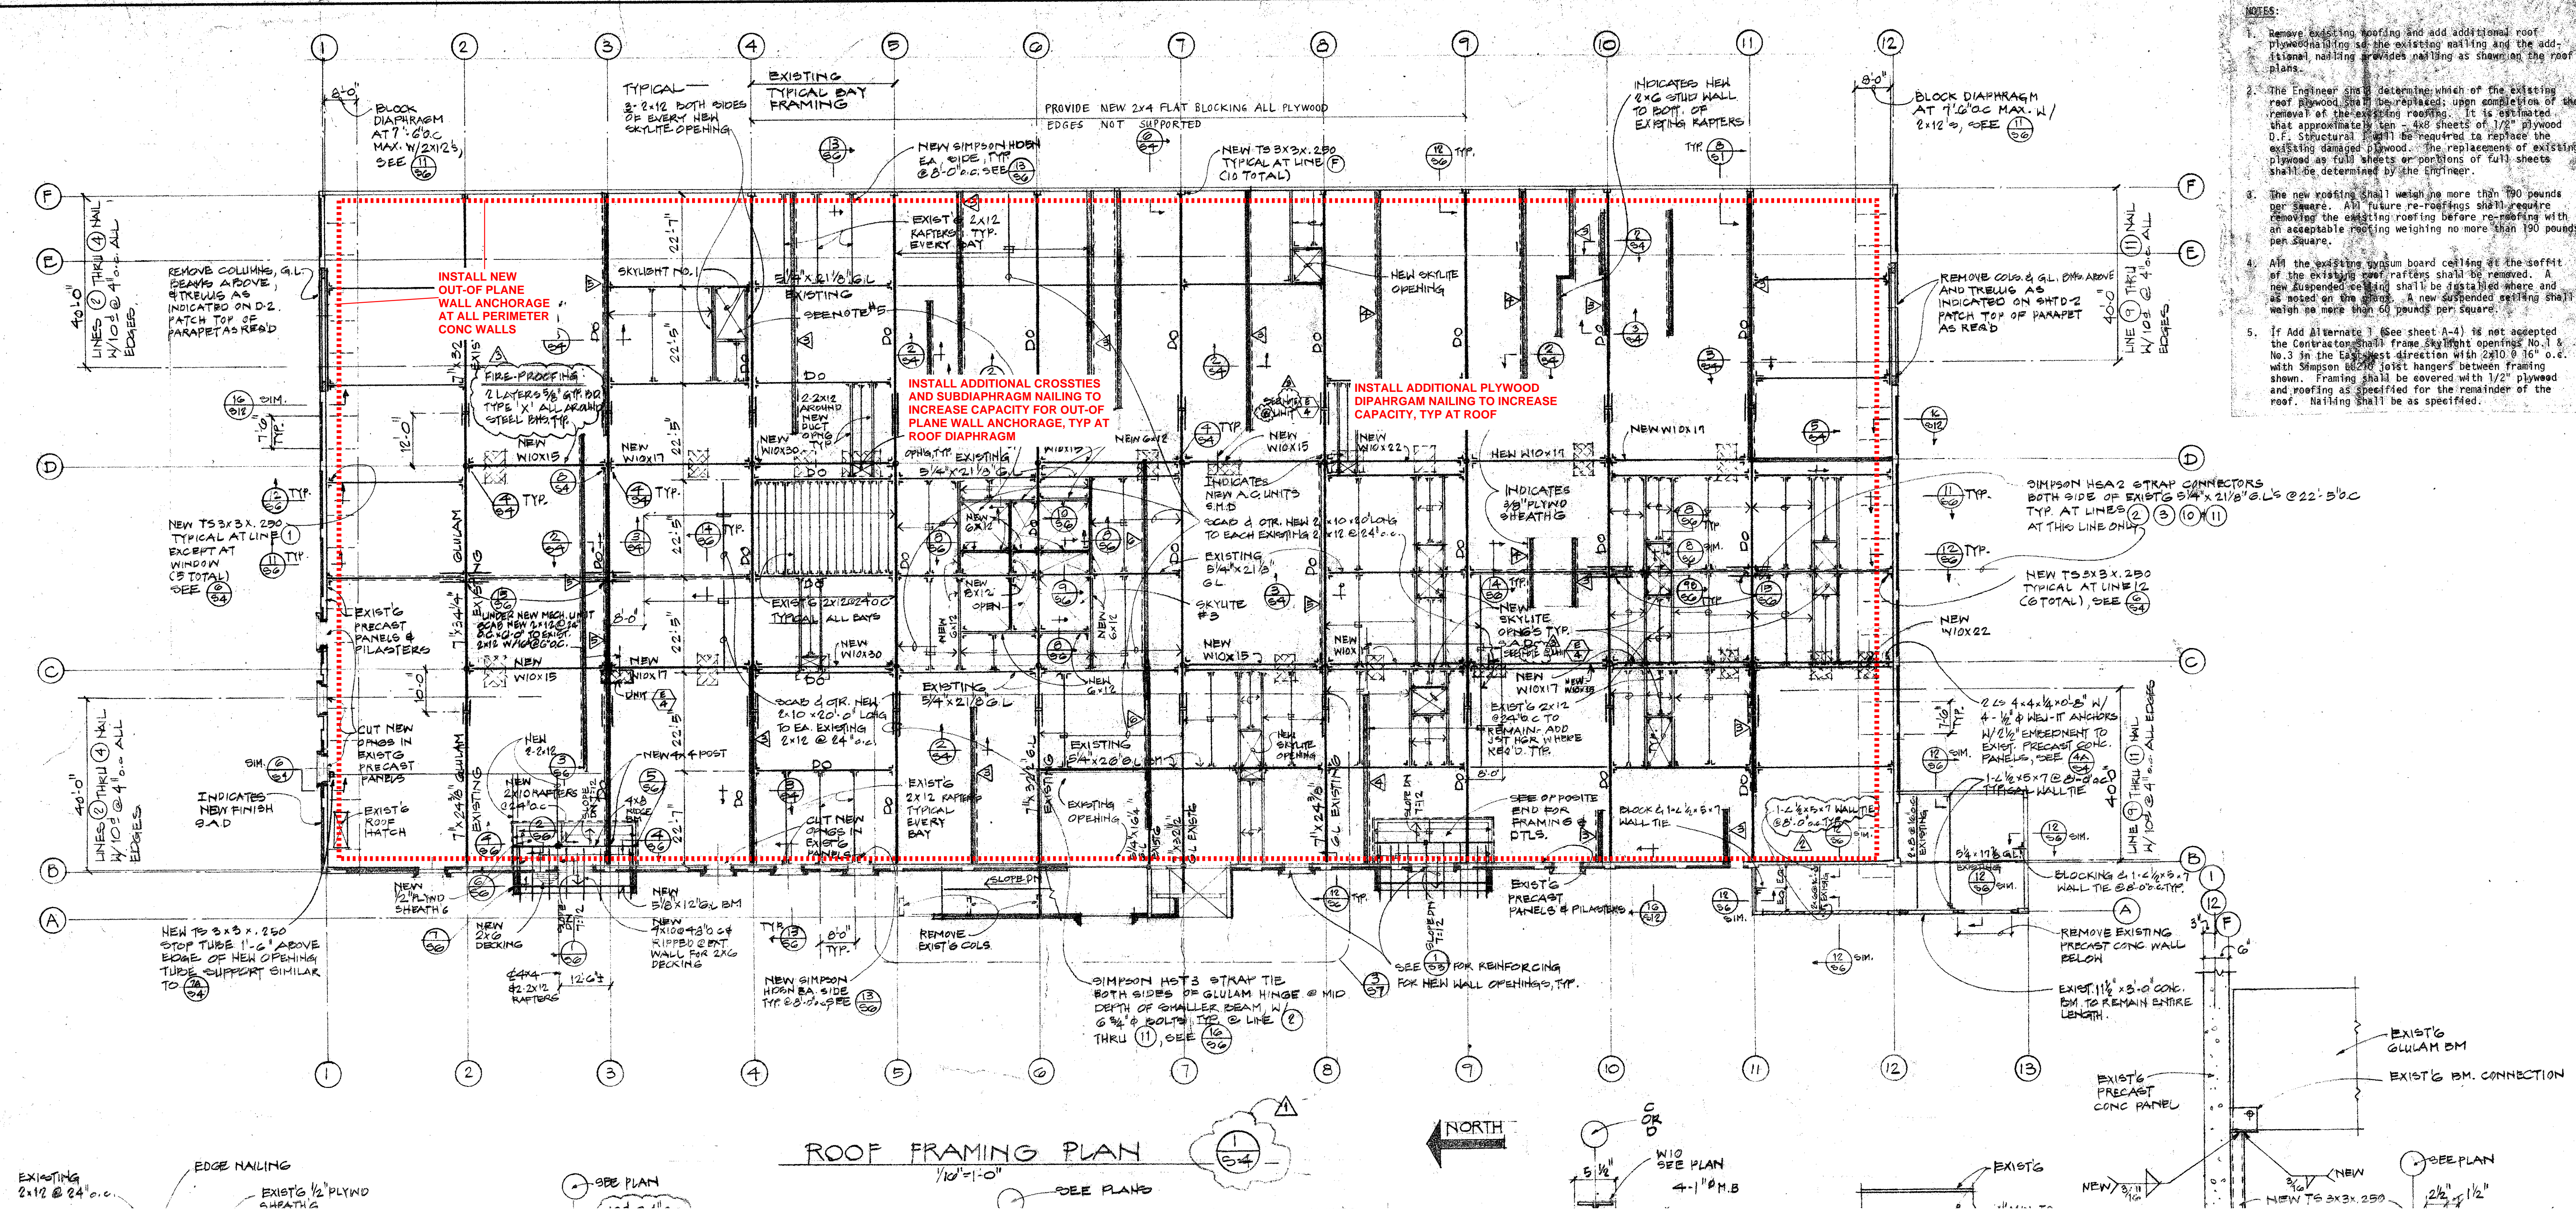
- The Engineer shall determine which of the existing roof plywood shall be replaced; upon completion of the removal of the existing roofing, it is estimated that approximately ten (10) sheets of 1/2" plywood D.F. Structural shall be required to replace the existing damaged plywood. The replacement of existing plywood as full sheets or portions of full sheets shall be determined by the Engineer.

- NOTES:**
- Remove existing roofing and add additional roof plywood nailing to the existing nailing and the additional nailing provides nailing as shown in the roof plans.
