Arborist Report

120, 130 E Grand Ave/129, 140, 160, 180 Sylvester Rd South San Francisco, CA 94080

Inspection Date: April 12, 2022

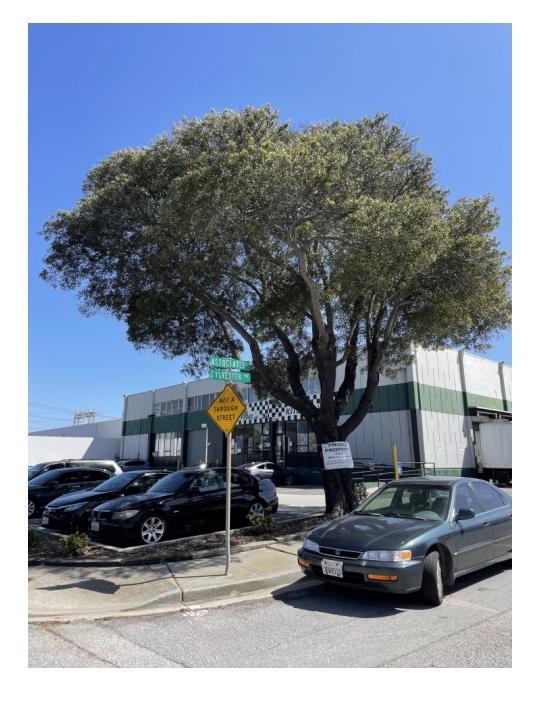
Tree #50

TAG NO.	COMMON NAME	DIAMETER AT BREAST HEIGHT"	H'/W'	HEALTH	STRUCTURE	PROTECTED (X)	TREE DISPOSITION	NOTES, RECOMMENDATIONS	
50	Black Acacia	29	35'/30'	f	fp	Х	С	DWR, EWR, lots of mechanical damage and wounds, sign bolted to tree, **Consider removal**	
51	Yucca	14.1	25'/12'	f	f		В	DWR	
52	Griselenia spp.	7.6, 8.3	18'/12'	f	fp		С	DWR, SP, growing against building, CD at base, **Consider removal**	
53	Syzigium spp.	4.2, 3.1, 2.2	20'/7'	f	fp		С	SP, growing against building, CD at base, **Consider removal**	
54	Stone Pine	16.8 at 2'	22'/13'	fg	fp	Х	В	EWR, SP, CD at 7'	Not part of proposed project
55	Juniper	22" at 1' above grade	25'	fg	fp	х	В	SP, CD, large bush splitting at 5'	
56	London Plane	5.1	18'/7'	f	fp		В	lean, CD at 7', SP	
57	London Plane	5.1	18'/6'	f	f		В	lean, SP	
58	Red Ironbark	11.2	28'/7'	f	fp		С	lean, previously topped, CD at 7', weight concentrated on one side	
59	Red Ironbark	8.5	18'/5'	f	fp		С	lean, overshadowed by dominant trees	Trees on adjacent site

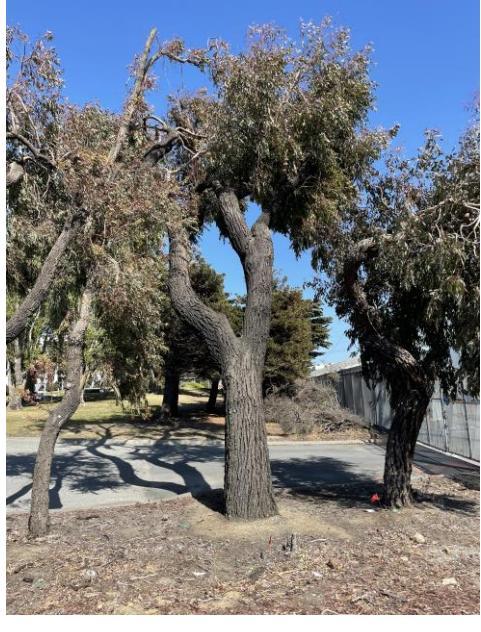
Tree #60

60	Red Ironbark	23.7	30'/30'	f	fp	х	С	lean, extremely unbalanced canopy, CD at 10'	
61	Red Ironbark	15.2	13'/8'	f	fp		С	extreme twists in trunk, unbalanced canooy, CD at 8'
