## MEMORANDUM

**Project:** 201 Baden Avenue  
GA Job #2019019

**Re:** Standards Compliance Review – 201 Baden Avenue, South San Francisco

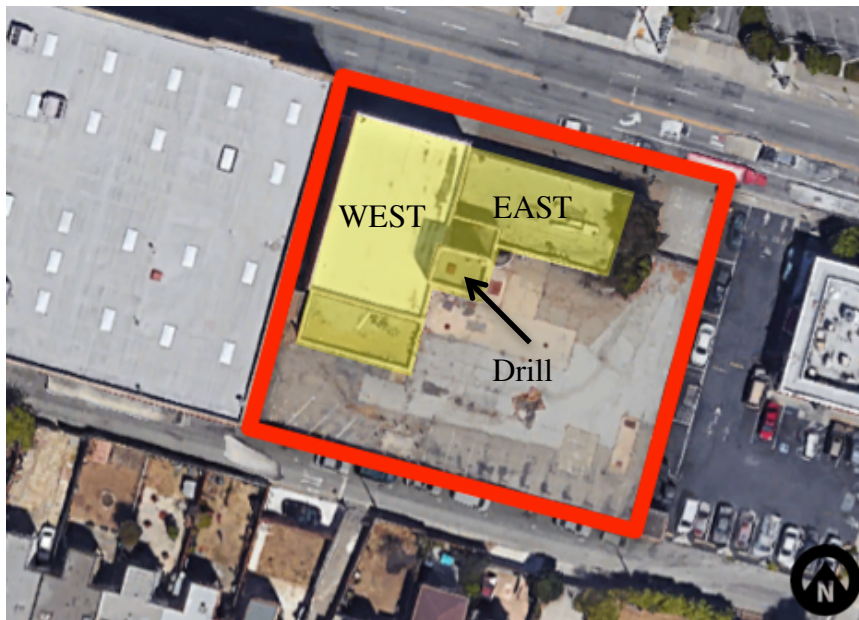
**Figure 1.** Aerial view of subject property outlined in red, with building highlighted in yellow and building volumes labeled (Google Maps, amended by author).

The fire station is a reinforced-concrete building comprised of three volumes of varying height, including: a one-story east volume, two-story west volume, and a five-story drill tower. All volumes have flat roofs covered with composition materials. The three volumes combine to form an L-shaped plan, with the drill tower situated south (rear) of the intersecting east and west volumes (**Figure 1**).
